# Current Approaches, Solutions and Practices in Conservation of Cultural Heritage

E-ISBN: 978-605-07-1592-7

DOI: 10.26650/B/AA9PS34.2024.006

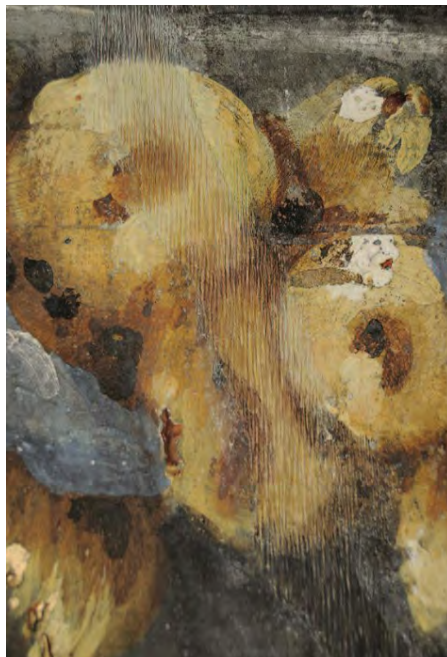
**Figure 1.** The example for *selezione cromatica* in the Church of San Nicolas Obispo y San Pedro Martir, Spain. (Ostrovcska, I. 2020. Aesthetic integrations in the restoration process of mural painting. *Journal of Architecture Urbanism and Heritage*, 3(2), 37-44, p. 40).

Full *tratteggio*-style retouching can be applied in two ways. The original *tratteggio* is *Riganto*: a system of vertical lines forms the colour (or pattern), which, when viewed from a distance, integrates the lacunae with the original *tratteggio* (Grenda, 2010). Another option is the *selezione cromatica* technique, where the alignment of the paint lines is not automatically vertical, but instead, the lines conform to the visual flow of the image (see figure 1). Another related technique is *astrazione cromatica* which was designed to be applied when there were more significant losses and there was not enough information about the original composition. The idea is founded on the supposition that neutral colour can be produced that harmonizes with the complete image and improves its ability to be reintegrated and understood (Grenda, 2010). The *astrazione* augments that neutral-toned fill with a limited pallet composed of primary colours and black, and combined with the toned fill, the intertwining lines create a vibrant colour screen (see figure 2).

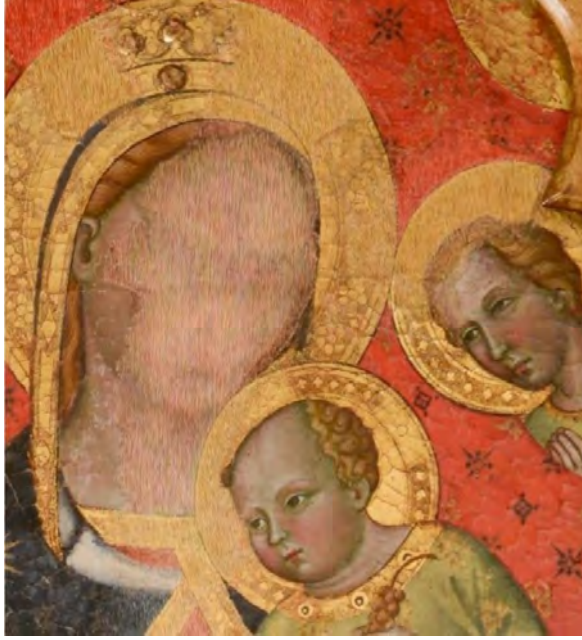
**Figure 2.** The example of ‘astrazione cromatica’ of Madonna’s face. (Ostrovcska, I. 2020. Aesthetic integrations in the restoration process of mural painting. *Journal of Architecture Urbanism and Heritage*, 3(2), 37-44, p. 41).

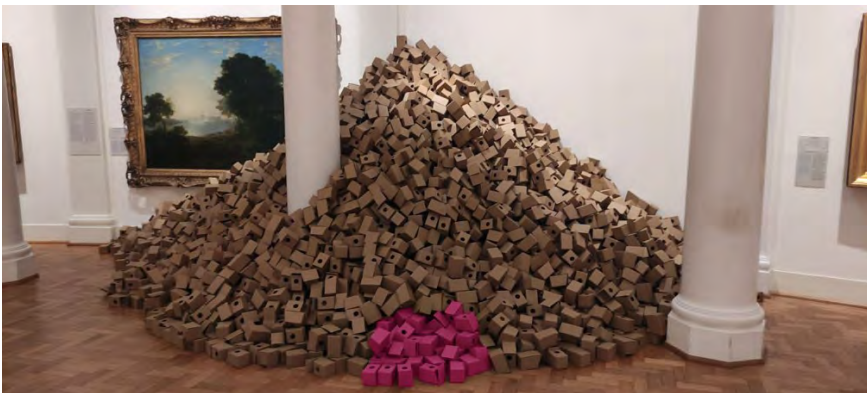
**Figure 4.** Representation of the recognisable intervention in the illustration program. (Photographed by; Ece Erman in Landscape Gallery at the National Museum of Art, National Museum Wales in Cardiff, 5 January 2023).

To develop the thought experiment with the Unlliw artwork. Imagine that during reinstallation in the museum, some of the boxes are lost or damaged; could different colour boxes signal their replacement? In this case, conservation would become part of this artwork's journey. How then to approach the essence of the art, the artist's intent, and a desire to reflect that process of loss and capture it in an honest and readable way? Are there any circumstances (perhaps related to how the loss occurred) where the replacements would be vivid such as bright pink (figure 5)? Might other circumstances related to the loss be responded to in more subtle ways, detectable to a careful viewer so that the replacement birdboxes are one tone darker or lighter than the colour of the boxes used in the artwork (figure 6)? Or could the boxes have the same colour and shape but different surface textures (figure 7)? Each of these ideas experiments with the recognisability of conservation interventions. A more subtle approach may create an unconscious assumption in most viewers that this was part of the artist's work, an invisible replacement would remove the loss even from the object's story and the bright pink event would call attention to it. An invisible replacement could remain detectable by a careful marking on a non-exposed surface edge or the use of fluorescent security markers, rendering it detectable to museum staff but invisible to the public. If we imagine different possible agents of change: slow decay under gallery lights; accidental wetting and mould due to poor cleaning practices; theft by young political activists seeking to extend the cause by carrying the bird box back to the housing site; a future artistic project that sought to distribute the birdboxes amongst galleries to signify alternative futures would each suggest the same response? The suitability of the conservation approach cannot be informed from an examination of conservation canon alone, it requires a culturally considered ethically informed, participatory, case-by-case discussion.

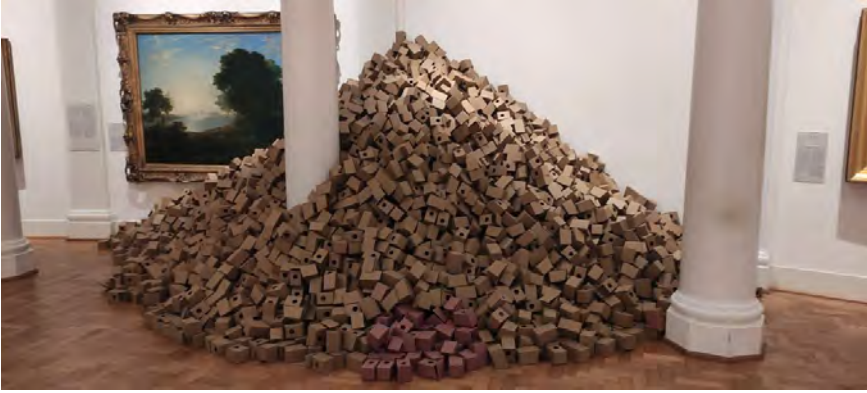
**Figure 5.** Designing the boxes that can be added to the work in a less conspicuous colour illustration program. (Photographed by; Ece Erman in Landscape Gallery at the National Museum of Art, National Museum Wales in Cardiff, 5 January 2023).

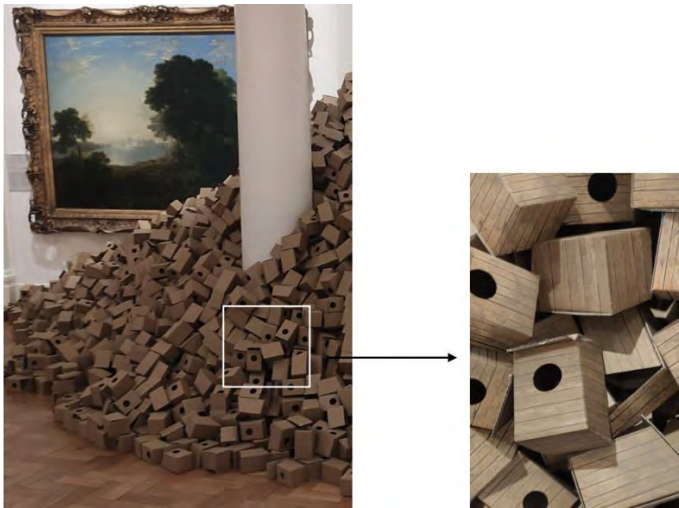
**Figure 6.** A version designed in the illustration program with a different surface texture application approach. (Photographed by; Ece Erman in Landscape Gallery at the National Museum of Art, National Museum Wales in Cardiff, 5 January 2023).

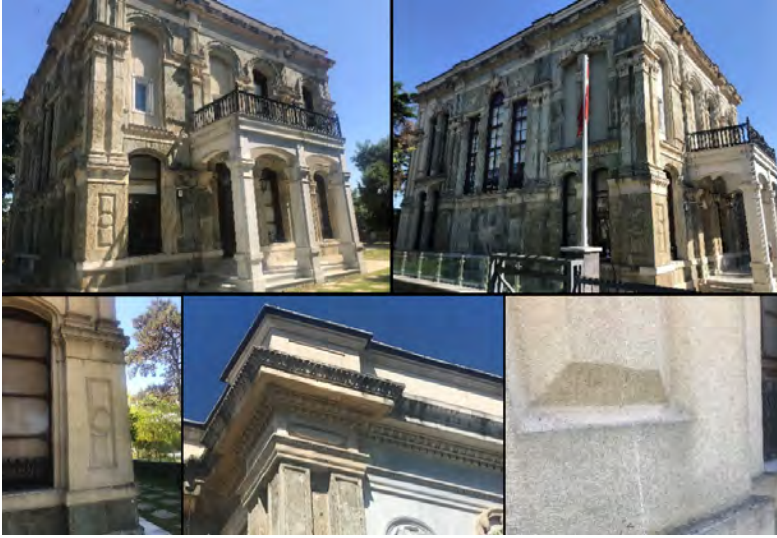
**Figure 4.** Reintegration applications using a type of limestone similar in color and texture during the 20<sup>th</sup>-century repairs (bottom) in place of the tuff stone used in the original construction of the Abdülaziz Hunting Lodge (top) during the reign of Ottoman Sultan Abdulaziz (1861-1876; photos by Sener, 2022).

Determining the materials used in the construction and decoration of a building allows the identification of both original and later additions in the masonry, building elements, and any cladding. For example, when determining the use of two different types of stone in the stone cladding of a building exterior, a detailed examination reveals that the damage had been filled in with different types of stone and the repairs to have been made from materials similar to the original (Figure 4).

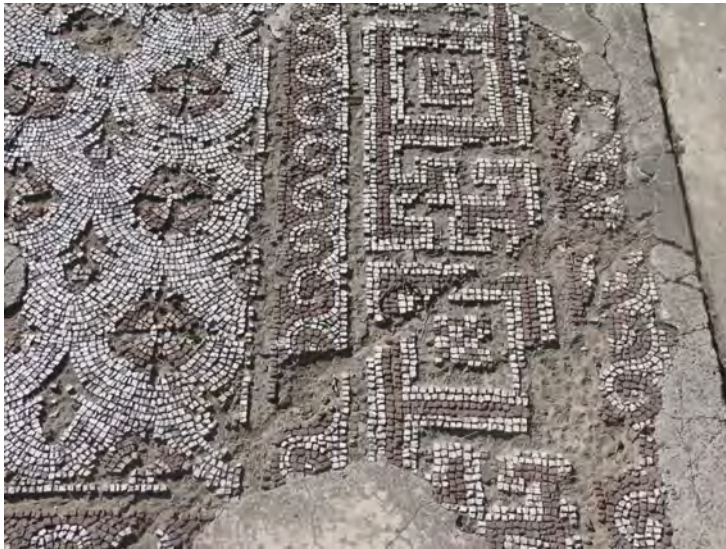
**Figure 5.** Advanced erosion of clayey sedimentary stones in a mosaic exhibited in an open area (Antakya Museum, Hatay, Türkiye; photo by Şener, 2009).

Examinations of the material are also used to identify conservation problems. In fact, when examining the sedimentary stone types used in the building, the siliceous, carbonate, or clayey structure of the components allows one to understand the causes of wear in order of least to most impactful (Figure 5).

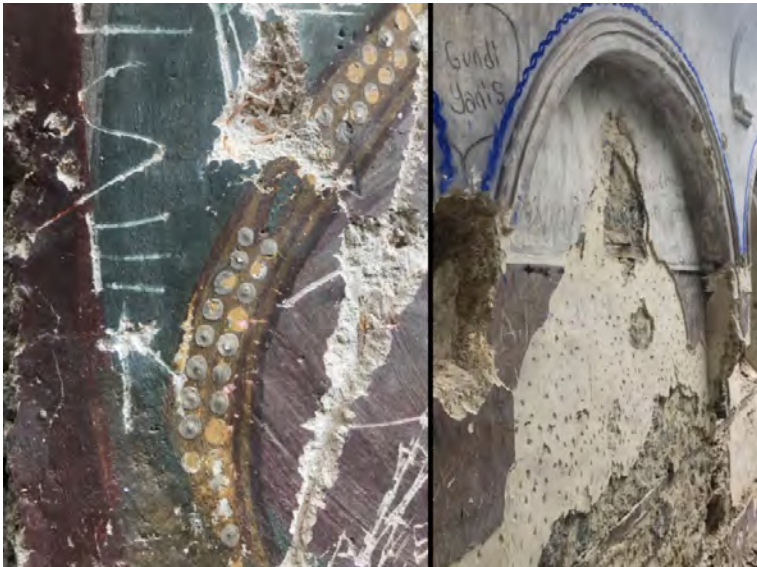
**Figure 7.** Vazelon Monastery (Trabzon, Türkiye), used from the Byzantine period until today. Right: Straw-added plaster material, which becomes visible thanks to spillage, and putty paints that have been embossed on the surface. Left: Notch marks on the wall painting showing the construction of new plaster over previous plaster (photos by Şener, 2022).

In a building decorated with wall paintings, determination made regarding the carrier, the plaster layers and the type of paint used on the plaster, as well as the decoration style, the wall painting technique (e.g., secco, fresco), any graffiti, and writing as belonging to one period or a later one can be used to determine the original construction, usage periods, period additions, and changes (Figure 7).

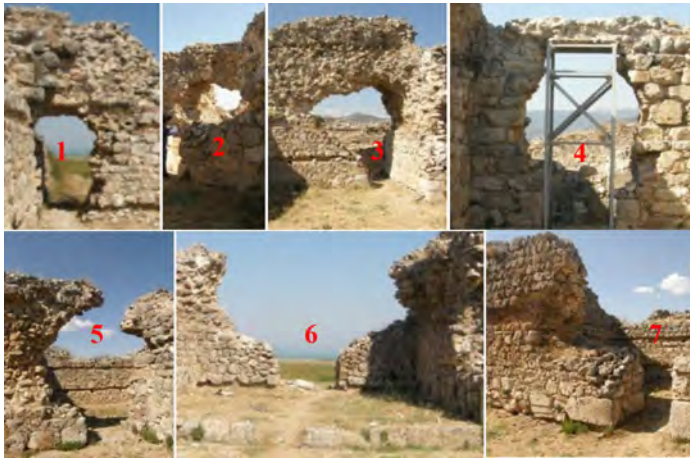
**Figure 9.** Seljuk period (13<sup>th</sup> century) Kubadabad Great Palace Building (Beyşehir, Konya, Türkiye). Even from one's initial observations of the building, the stages of structural loss can be observed on the walls and around the door openings (photos by Şener, 2011).

This covers the examinations and research regarding identifying the changes, deteriorations, and damage that has occurred in a work according to the original features (Figure 9).

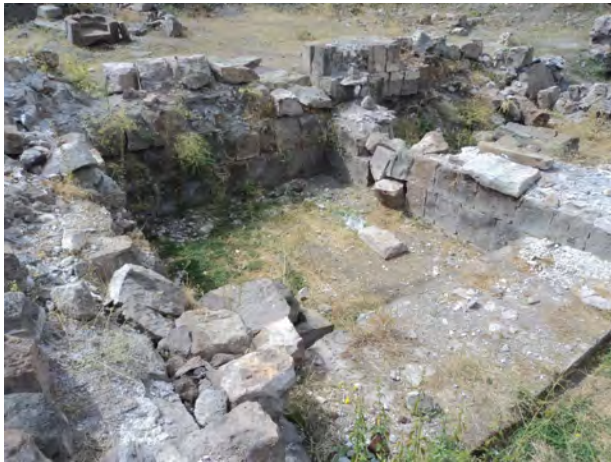
**Figure 10.** Medieval bath structure in Ahlat. The surrounding earthen fill, the exposure of the tops of the walls and the effects of the continental climate cause further structural losses in the building remains (photo by Şener, 2015).

Deterioration of movable objects or a monument and determining their causes constitute the basic diagnosis with regard to determining intervention decisions and implementations (Figure 10). For example, the restoration decision that requires partial braiding for reinforcement is made in order to eliminate a problem such as a unit material loss in the braid. For the problem of surface loss caused by salt crystallization due to water absorption and frost, a restoration decision such as desalination followed by imitation reintegration can be made. However, because these decisions will not be sufficient, iother intervention decisions may also be required, such as creating a drainage system or cleaning the earthy fillings around a building in order to prevent possible risks and future deterioration.

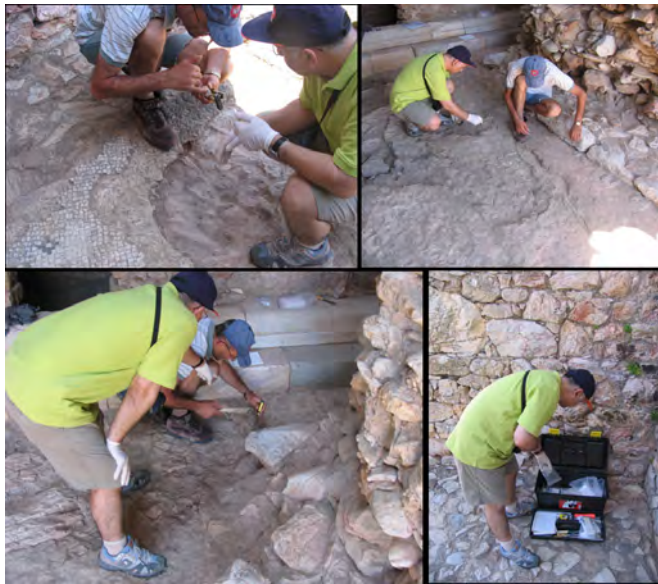
**Figure 11.** Repair project for Bodrum Torba Monastery Mosaics (Torba, Bodrum, Türkiye). Mosaic sampling studies in cooperation with conservation expert and archaeometric specialist (photo by Şener, 2006).

This covers the observations, technical studies, and research on cultural assets, from age determinations to identifying the types of construction and ornamental materials and understanding the deterioration and deterioration mechanisms. Most of the various professions and scientists take part in such studies based on the types of materials (Figure 11).

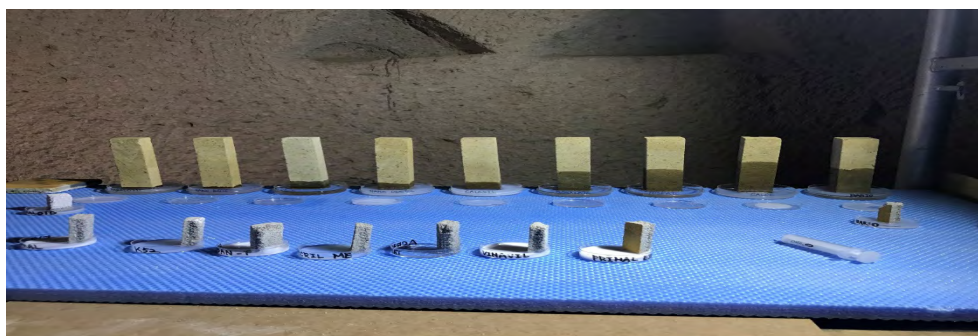
**Figure 12.** Experiments for monitoring the absorption levels of known consolidation types in building stone tuffs in Tagar Church (Cappadocia, Türkiye) within the scope of the Emergency Response Training Project on Murals carried out by Turkish, Italian, and Japanese conservation experts between 2017-2019 (photo by Şener, 2018).

When selecting the materials for reinforcement and surface protection that can be used for problems such as chipping on the surfaces of stones, mortars, and plasters, trials are made on materials (samples) similar to the original. Properties such as absorption depth, adhesion and cohesion, reversibility, and transparency of the material that were determined for consolidation applications are reviewed, and decisions are made according to the obtained results (Figure 3).

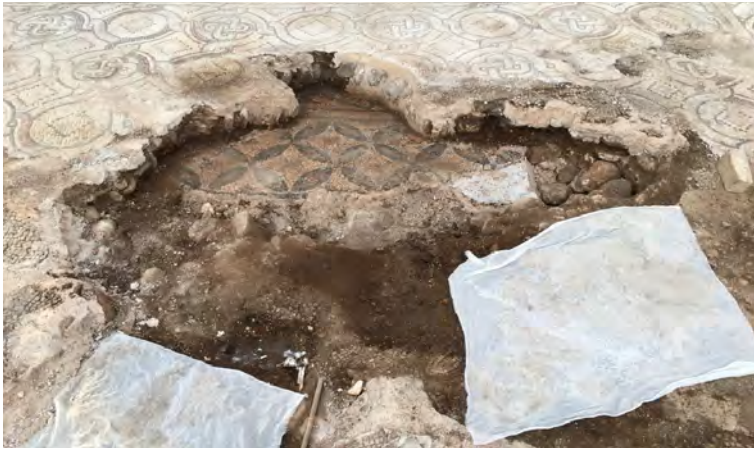
**Figure 13.** In 2017, the tessellatum layer of a previous period was revealed during the cleaning of earthen fill in lacunae during the restoration carried out on the central nave floor mosaic of Ölüdeniz Church (Fethiye, Muğla Türkiye; photo by Şener, 2017).

In the mosaics unearthed by archaeological excavations, one can encounter layers of tessellatum from previous periods of use in a lacuna, whose earthy filling was cleaned during the restoration work (Figure 4). In such a case, one needs to make a new intervention decision and review the implementation decisions while the implementation is ongoing.

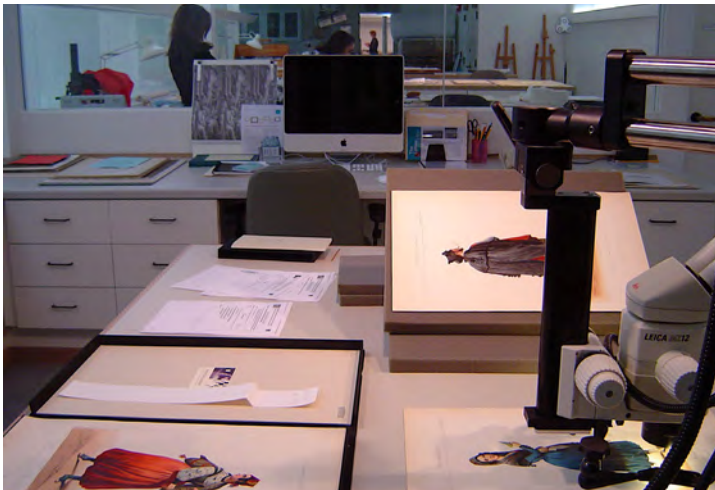
**Figure 5.** Photograph taken during conservation treatment of *Galerie Royale de Costumes: Costumes Espagnols*, Publisher Aubert & Cie, Paris 1852, collection of the Art Institute of Chicago  
Credits: Malina Belcheva. Courtesy of the Art Institute of Chicago

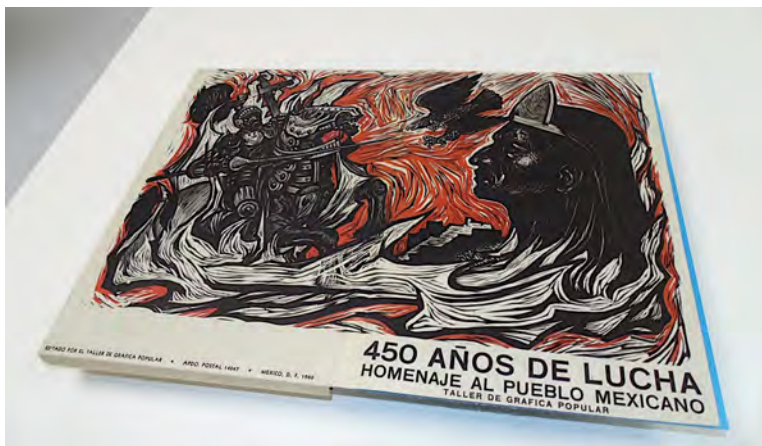
**Figure 9.** Adolfo Quinteros, *Cuauhtémoc*, Mexico, 1960, after undergoing conservation treatment, collection of the Art Institute of Chicago

Adolfo Quinteros (1928–1994) created the linocut gravure titled *Cuauhtémoc*<sup>5</sup> in 1960. This piece portrays Aztec resistance to the Spanish conquistadors. Printed on cream cardboard using letterpress in red and black ink, this work constituted the cover of *450 Years of Struggle: Homage to the Mexican People*.<sup>6</sup> This luxe album<sup>7</sup> comprised a collection of 146 finely printed folio-format graphics on colored paper. Created by twenty-five Mexican artists, the graphic works were dedicated to the Mexican War of Independence of 1810, the Mexican Revolution of 1910, and the Nueva Rosita miners' strikes in the 1950s. Figure 9 shows *Cuauhtémoc*, in which the artist depicts the entrancing Aztec legend of the *Descending Eagle*. Quinteros adhered to the principles of *Taller de Gráfica Popular* that “art must reflect the social reality of the times.”<sup>8</sup> Hence, he symbolized the significance of the last Aztec ruler Cuauhtémoc, “one who has descended like an eagle,” visually implying the fierceness and determination of the Mexican People in times of war. (Figure 9 and 10)

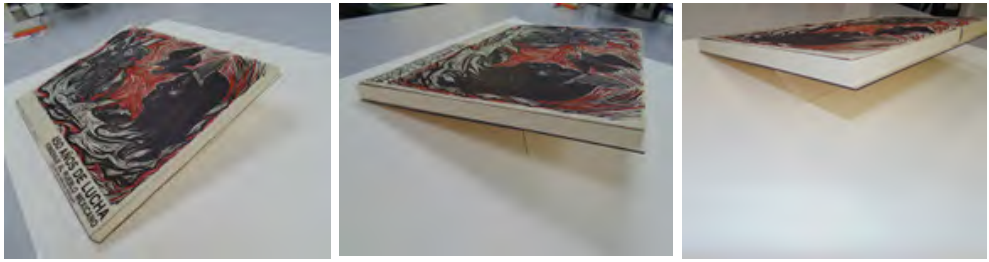
**Figure 10.** Conservation treatment and exhibition cradle design for *Cuauhtémoc* from the portfolio cover of *450 Years of Struggle: Homage to the Mexican People*  
Credits: Malina Belcheva. Courtesy of the Art Institute of Chicago

Captivated by the supreme influence of Quinteros' graphic art, the curator of the exhibition intended to display its portfolio cover in an open position. Originally, the artwork was extended and folded along the front, spine, and back cover of the portfolio. This structural characteristic complicated the conservation treatment and the creation of the cradle design. The exhibition installation for *Cuauhtémoc* proved challenging because the preliminary conservation treatment proposal initially envisioned preparations to display the object completely open, albeit only during the exhibition. The piece would later be restored to its original state.

Consequently, the conservation treatment began as usual with dry cleaning of the object with a volcanic sponge and *Staedtler Mars eraser crumbs*, followed by controlled humidification of the central spine fold of the cover. Next, pigment abrasions and paper losses were consolidated. The portfolio cradle support was finally created.

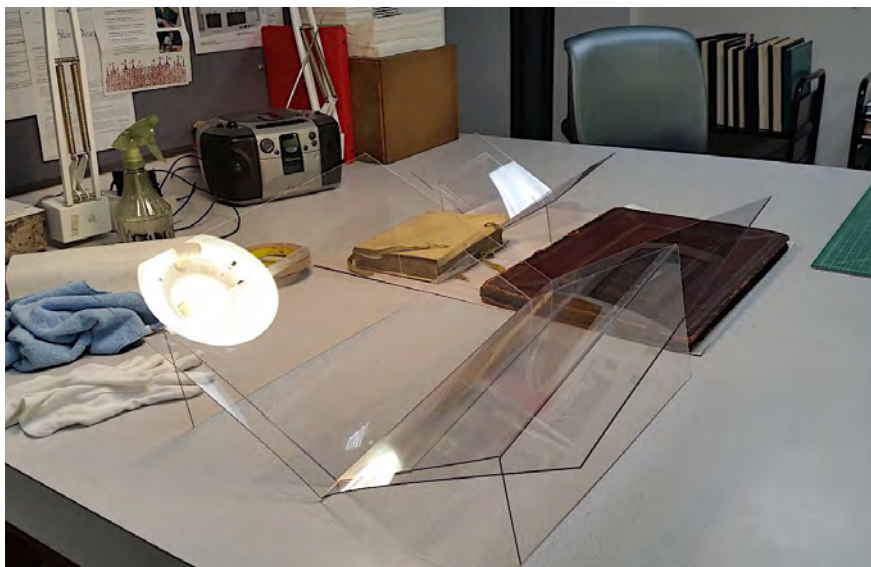
**Figure 12.** Vivak book cradles custom designed for the exhibition titled *Van Dyck, Rembrandt, and the Portrait Print* Credits: Malina Belcheva. Courtesy of the Art Institute of Chicago

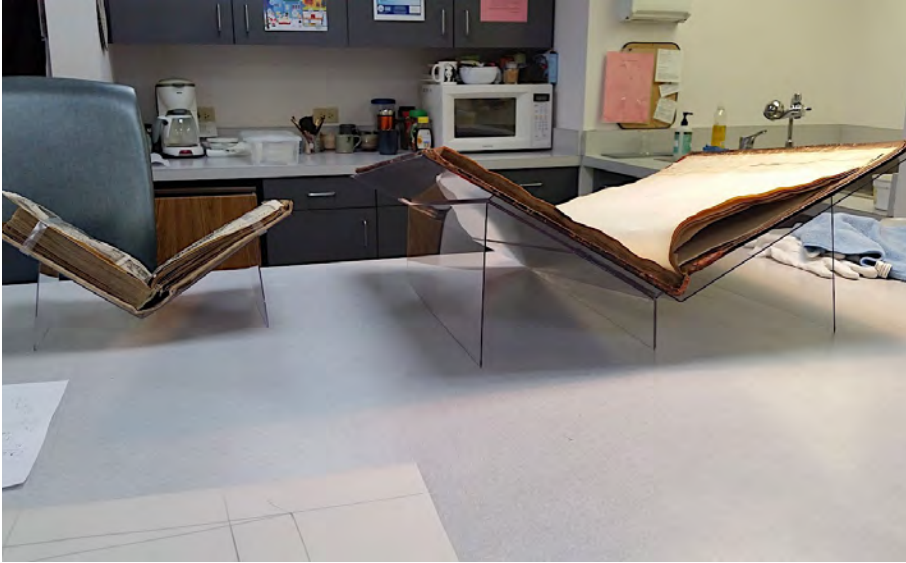
**Figure 14.** Unobtrusive cradles uniquely designed to completely support album structures using minimal material. Book cradles created according to the curator's specific preferences for the opening of the books  
Credits: Malina Belcheva. Courtesy of the *Art Institute of Chicago*

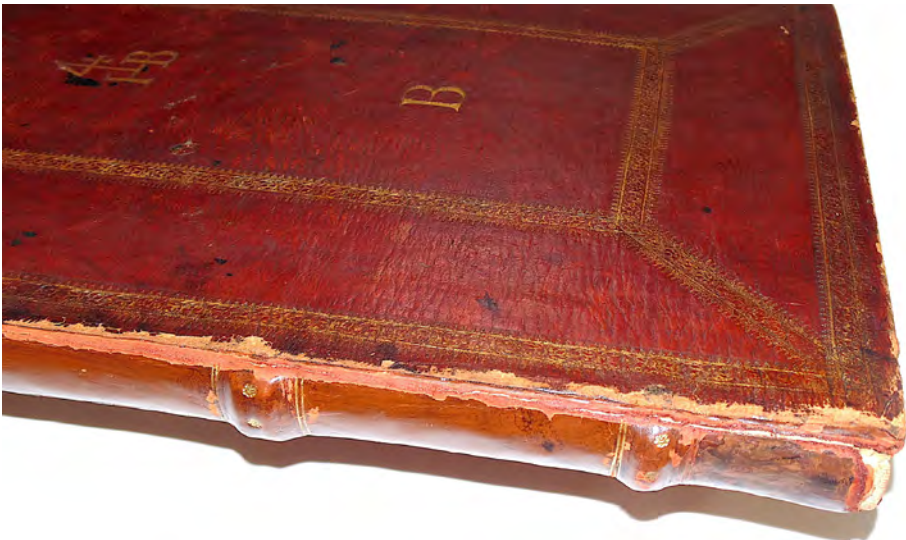
**Figure 15.** A close-up photograph of the album spine, tail, and front cover before the conservation treatment  
Credits: Malina Belcheva. Courtesy of the *Art Institute of Chicago*

The first conservation examination of the album binding, text block, and graphic works concluded multiple prior conservation and restoration campaigns. As there were no conservation records at the museum documentation, the time period of the preceding conservation treatments was difficult to be determined. Observations of the binding condition revealed a range of materials applied on the binding covers, spine, and endsheets of the volume implemented by previous conservators during the stabilization of the album structure, its rebinding, and text block repair.

As consequence of the existing repairs, and changes to the album binding structure, for over a period of more than three hundred years, the conservation examination defined the album condition as: *primary*, containing characteristic features related to the original, also first intended binding, and *secondary*, regarding to binding modifications implemented during prior conservation treatments.

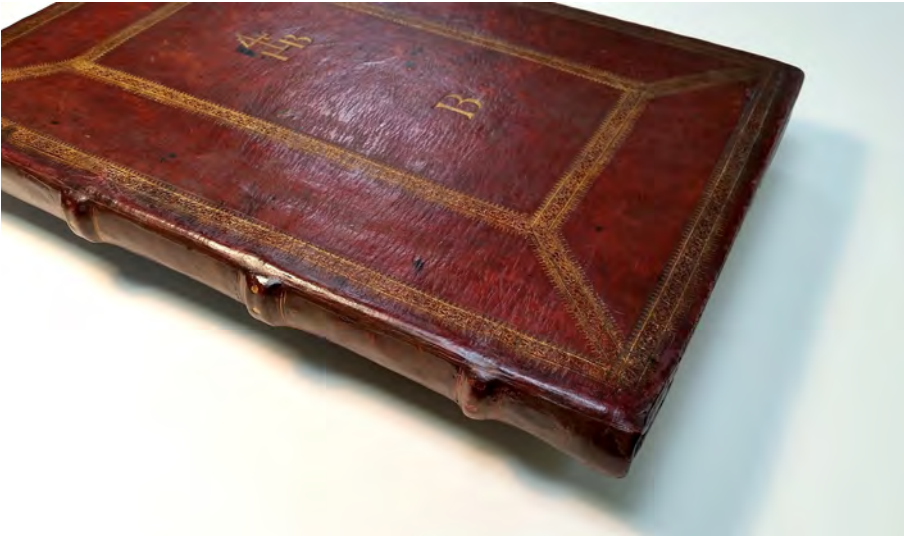
**Figure 16.** Photograph of the front cover and spine of the album after conservation  
Credits: Malina Belcheva. Courtesy of the Art Institute of Chicago

This complex conservation treatment encompasses consolidation and reconstruction of the binding losses, preceded by a compositional analysis of the original and secondary binding materials. Based on extensive conservation studies, stabilizing the album condition enhanced the flexibility and solidity of the binding and successfully integrated historical repairs with contemporary conservation materials. After the conservation treatment, an exhibition cradle was uniquely designed and custom-made using acrylic sheets of Plexiglas to fully support the folio album during the exhibition display.<sup>13</sup> (Figure 16, 17 and 18)

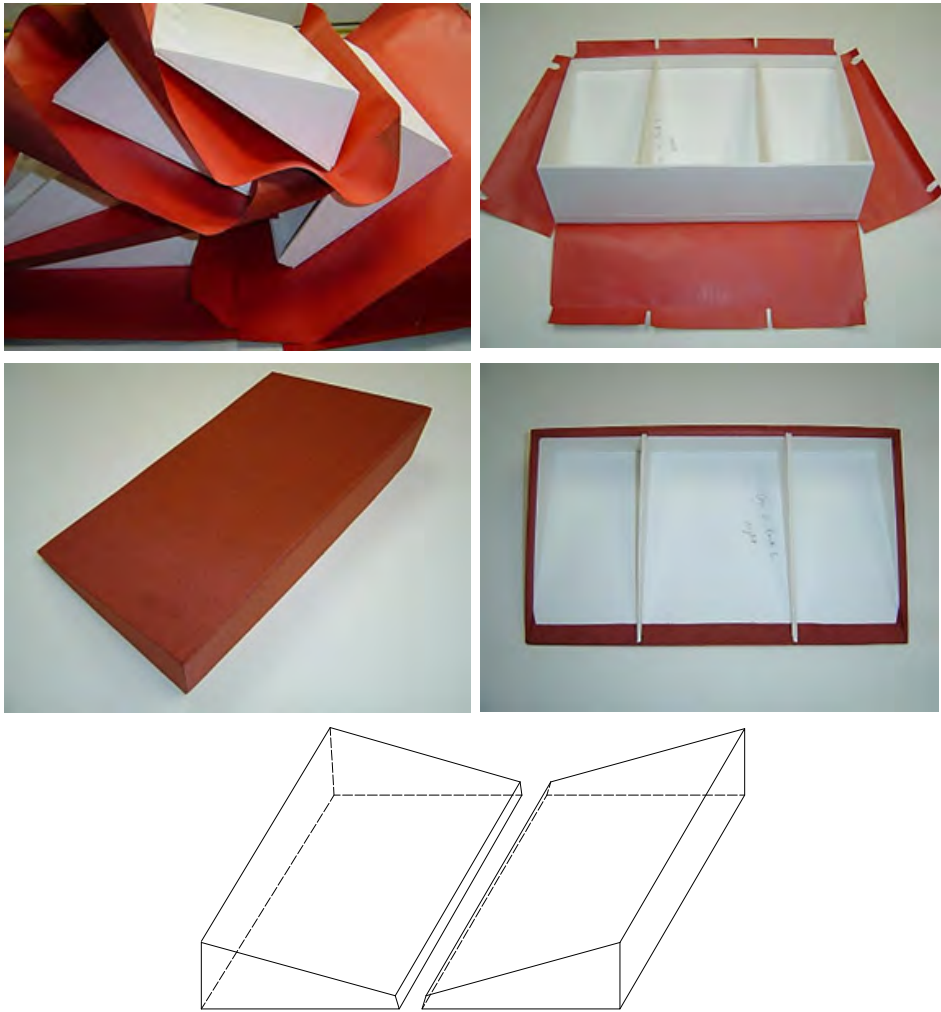
**Figure 21.** The sequence of preparing an exhibition cradle using a foam board covered for aesthetics with the same Japanese Silk textile utilized for the vitrine base layer.

Important from the conservator's viewpoint is the exhibition design of the supports constructed from a foam board for the oversized folio album collection of decorative art books presented at *Beauty and the Book: 19th and Early 20th Century Folios on the Decorative Art*. The photographs that follow depict the gallery view of the exhibition and the exhibition supports covered with Japanese silk. (Figure 20 and 21).

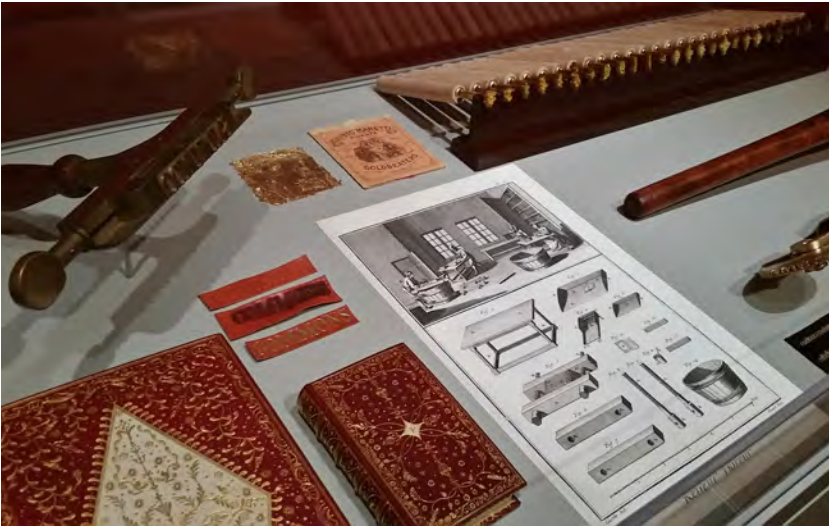
**Figure 22.** Gold leaf display next to period reproductions of Trevor Lloyd's Irish bookbinding and Philip Maddock's personal finishing tools  
Credits: Malina Belcheva. Courtesy of the Art Institute of Chicago

Figure 22 depicts the exhibition installation of an unusual museum object, a gold leaf<sup>16</sup>. A single gold leaf was taken from a historic gold leaflet book and displayed in an acrylic vitrine. The gold leaflet book belonged to collector and exhibition patron Philip Maddock.<sup>17</sup>

Unaware of the unstable properties of the gold leaf produced for bookbinding, the exhibition curators planned its installation in a didactic vitrine. Several factors should have been considered for the successful realization of this unusual installation. The gold leaf lightweight and extremely delicate; characteristics incited the decision the leaf to be underlined with Japanese tissue for additional stability and thickness, through which it adhered to the vitrine surface. The installation outline and sequence of treatment and preparation of the gold leaf for display are published by the author in “A Gold Leaf Installation,” an essay that includes commentaries on the selection of adhesives and experimental processes for the gold leaf underlining technique (see Figure 23).

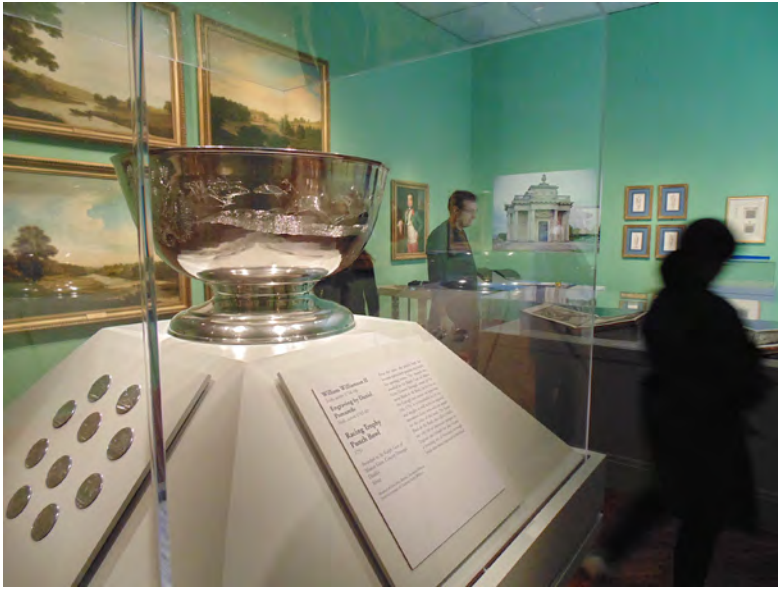
**Figure 26.** Photograph taken during the preparations for the exhibition titled *Ireland: Crossroads of Art and Design, 1690–1840*. The museum display case was designed by *Goppion Technology*. Credits: Malina Belcheva. Courtesy of the *Art Institute of Chicago*

The **temperature and humidity** in the exhibition vitrines must be controlled, observed, and recorded during the exhibition.

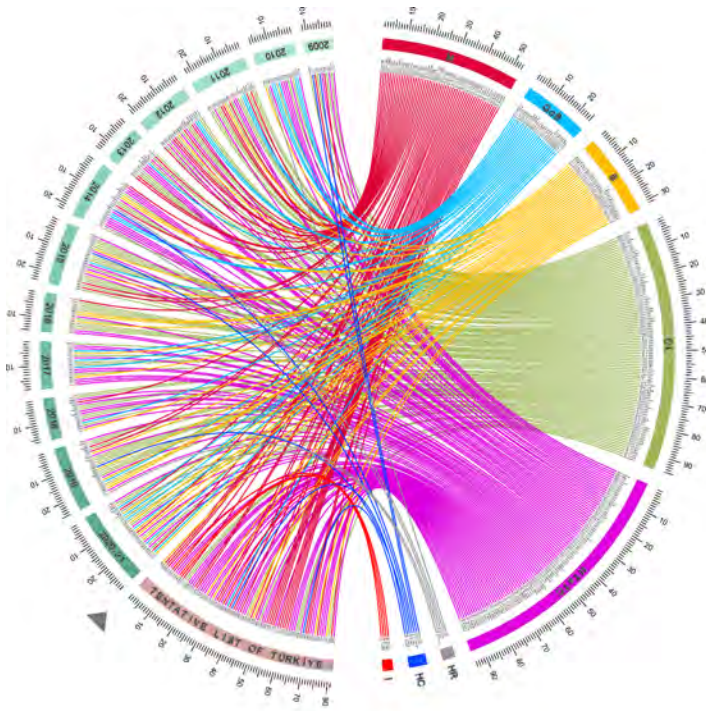
As a result of the research over a total of 314 observations that were divided into eight classes, 54 fall under the Monuments (M) classification, 25 under the Groups of Buildings (GoB) classification, 31 under the Sites (S) classification, 95 under the Cultural Landscapes (CL) classification, 94 under the Historic Towns and Town Centres (HTaTC) classification, five under the Heritage Routes (HR) classification, seven under the Heritage Canals (HC) classification, and four under the Incompatible (I) classification. The classification study of the observations has been visualized in the radial diagram in Figure 3. Each observation is represented in the diagram by the observation number described in Figure 2. To the left of the diagram, the observations are lined up counterclockwise in the order in which they are listed. WHL observations are grouped by the year they are listed. To the right of the diagram, the observations are listed clockwise separately by heritage classification. The transition relation of each observation from left to right side is indicated by lines with the heritage classification color. The outermost ring of the diagram has an indicator describing the number of observations in each group and classification.

**Figure 3.** Diagram of the classification of observations.

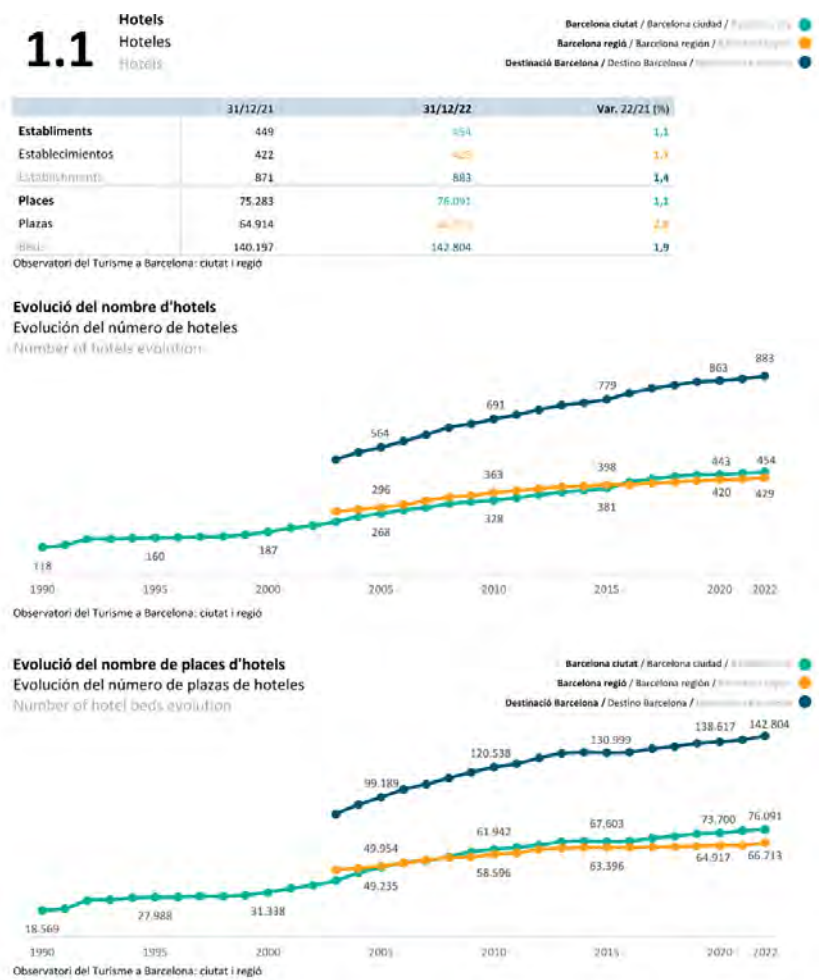
Tourism activity decreased in Barcelona due to restrictions imposed during the novel coronavirus (COVID-19) pandemic. However, tourist footfall increased at the usual pre-COVID-19 rates in 2022. Figure 5 displays the diachronic increase in tourists and overnight visits to Barcelona's center and its wider regions from 1999 to 2022 (Observatori del turisme a Barcelona, 2022).

Figure 5. Evolution of tourists in hotels in Barcelona (1990–2022)

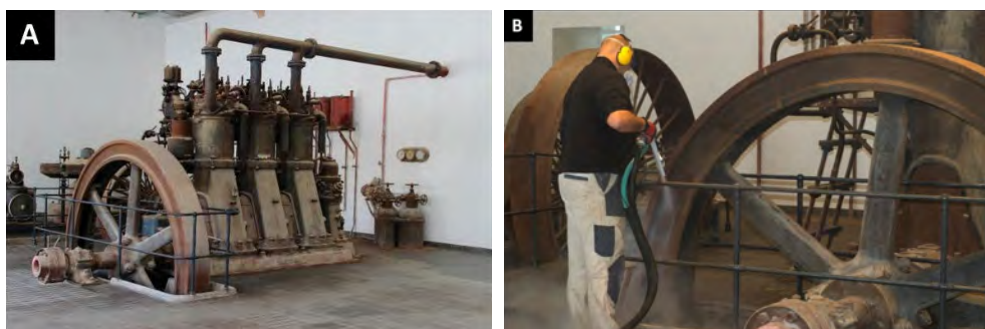
**Figure 1.** A) The 1927 diesel engine from the Société Suisse de construction de locomotives et de machines (SLM) (Winterthur, Switzerland) installed at the Levada de Tomar powerplant (Portugal). B) Diesel engine cleaning process using CO<sub>2</sub> technique (Photos: M. Tissot, Archeofactu).

This technique has been applied to remove bitumen layers and paint coatings from small metallic objects of cultural interest (Cutulle and Kim 2015). In large objects in an industrial context, we mentioned the case of the cleaning of a three-cylinder engine of the Tomar powerplant in Portugal (Tissot, Lemos, and Filipe 2016). In this case, it was possible to recover marks of use made on the coating layer and covered by corrosion products (Figures 1 and 2). The operation time decreases considerably, although the equipment and dry ice costs are high. Nevertheless, the time/cost benefit is positive.

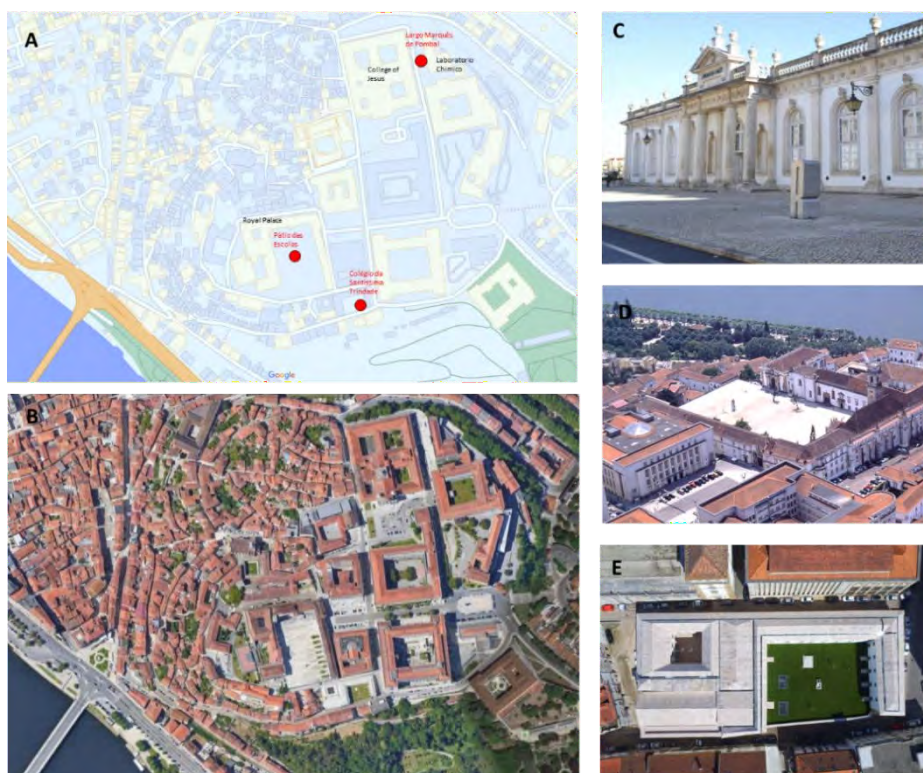
**Figure 2.** Plant (A) and aerial view (B) of the University of Coimbra area, with indication of the excavation sites, and modern photographs of the sites: Largo Marquês de Pombal (C), Pátio das Escolas (D), and Colégio da Santíssima Trindade (E).

(Helena Catarino and Sónia Filipe [2000-2001]), *Colégio da Santíssima Trindade* (Helena Catarino, Sónia Filipe and Vera Santos [2002-2006], and in *Largo Marquês de Pombal*, in the space between the *Laboratório Chimico* and the former *Colégio da Companhia de Jesus* (Sónia Filipe [2010-2011]) (Figure 2).

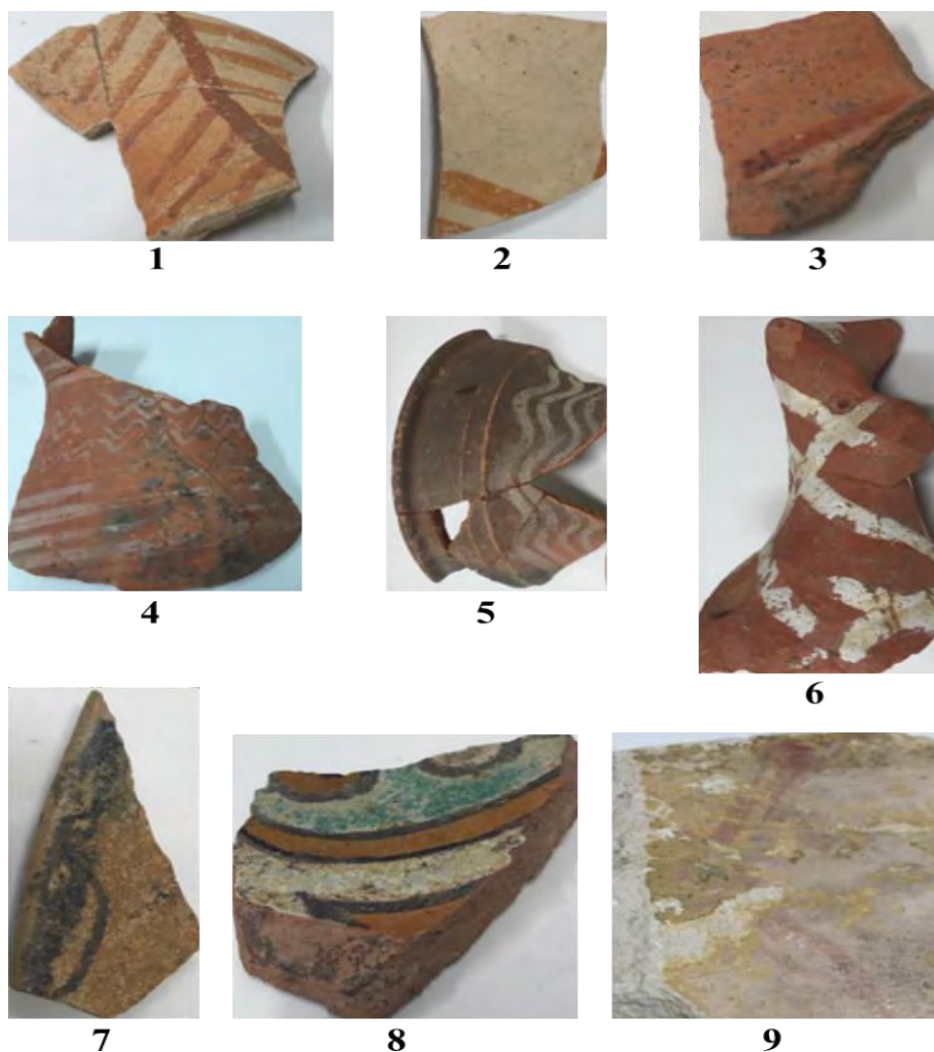
**Figure 3.** Images of the studied archaeological objects.

The pieces belonging to the Islamic period also share some similarities. All of them have a red-brownish paste, and pieces 4, 5 and 6, show the most common type of decoration in the region of Coimbra, *i.e.*, the white painting of a set of linear patterns. The paint strokes were applied directly to the surface of the piece or with an engobe covering of the same colour as the paste, or slightly darker (Catarino et al. 2009). More specifically, the piece with reference number 4 corresponds to a fragment of a jug, with a homogeneous red paste and white paint on the neck and body of the piece, presenting a decorative motif formed by parallel and wavy bands applied over reddish engobe. Comparative studies allowed this piece to be defined in a chronological horizon between the 10th and 11th centuries. Piece 5 corresponds to a pitcher of homogeneous red paste, exhibiting another engobe on which white paint has been applied, with wavy bands on the neck of the piece. We can frame it in a cultural horizon corresponding to the 12th century (Catarino et al. 2009). Fragment 6 corresponds to the head of a small zoomorph (an equid) and is part of a piece whose initial shape was not possible to reconstitute. Pieces of this nature can be framed in chronological-cultural horizons attributable to the Islamic and Medieval periods, as well as later, in contexts of production of the Modern period. The stratigraphic unit from which the piece was exhumed, as well as its dimensions and formal characteristics, do not allow us to safely exclude any of the possible scenarios.

Contrary to pieces 4-6, fragments 7 and 8 feature decorative paintings on glazed support surfaces. In the archaeological substrate of the city of Coimbra known so far, this type of decoration can be monochromatic or dichromatic, standing out, as in the case of the studied

pieces, open shape objects decorated in green and white, and in dry rope, total or partial. The fragment of *ataifor*/dish number 7 has a monochromatic glazed exterior surface, in a luscious tone, and an interior showing green and black traces on white, that correspond to the common production in the 10th/11th century. Fragment 8, on the other hand, corresponds to a plate, made of red homogeneous paste, with an exterior surface also glazed in monochromatic, in a honeyed tone, but an interior surface decorated with a total dry rope. It corresponds to a ceramic production marked out between the 11th and 12th centuries. The piece has different coloured regions, in orange, black, white and green tones.

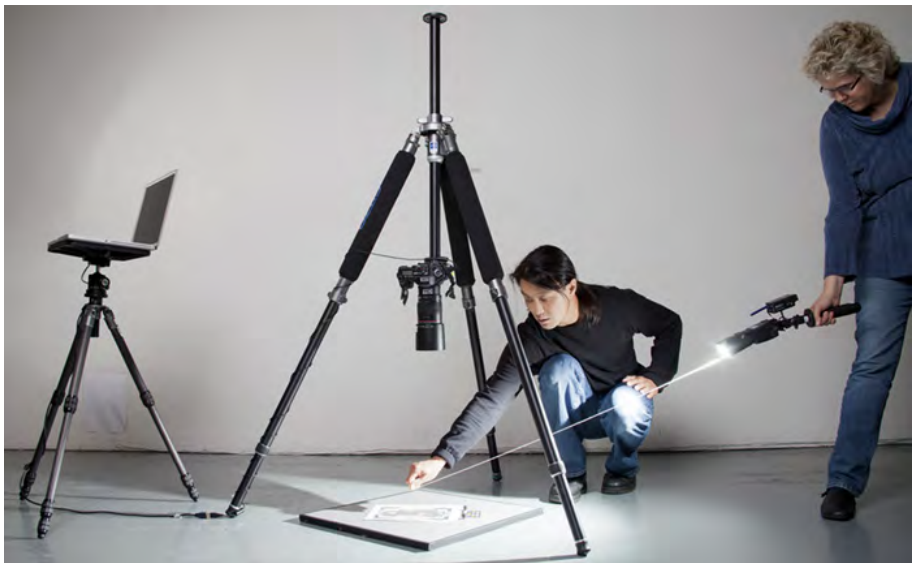
Figure 5. RTI shooting without fixed hardware. (Schroer, 2012)

Although fixed hardware provides speed and high accuracy, imaging can be performed without the use of such systems. In this method (where the camera is fixed), the light is moved manually for each photo. Para flash or continuous light sources can be used (Fig. 5). Spheres with black or red glossy surfaces are placed close to the subject so that they enter the frame. Then, at the same distance from the center, the light source is reflected on the object's surface from different angles. In each frame, the light source causes a point-shaped reflection on the spheres with a bright surface. These reflections can be determined by the algorithms of the RTIBuilder software, and the stroke angles of the light can be determined. When applying the method, the distance of the light from the center is different in each frame and the overlap of the reflections in the spheres with bright surfaces causes errors in the RTI file (Earl et al., 2011, pp. 149–150; Cultural Heritage Imaging, 2013a).

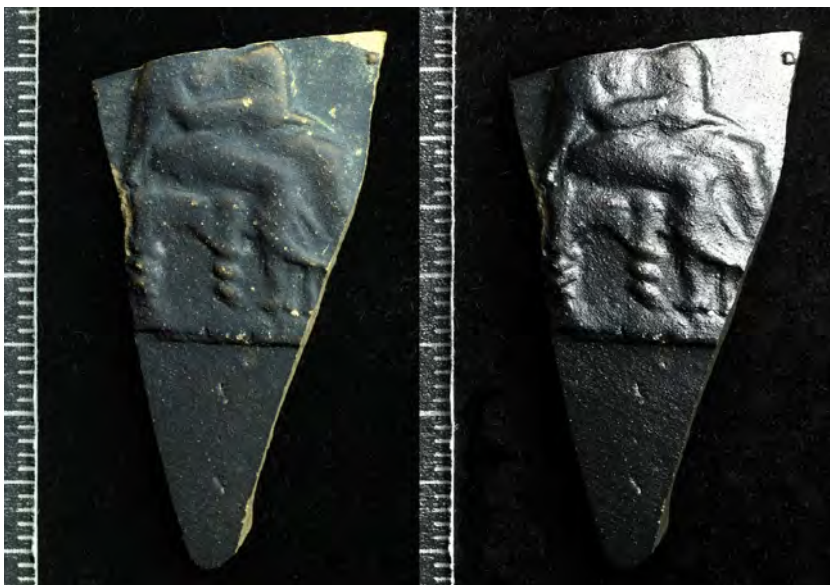
**Figure 9.** A piece of ceramic depicting Dione and Aphrodite under normal light (left) and after processing with RTI (right). ([www.timesofisrael.com/imaging-technology-reveals-birth-of-athena-on-2300-year-old-shard-from-galilee/](http://www.timesofisrael.com/imaging-technology-reveals-birth-of-athena-on-2300-year-old-shard-from-galilee/).)

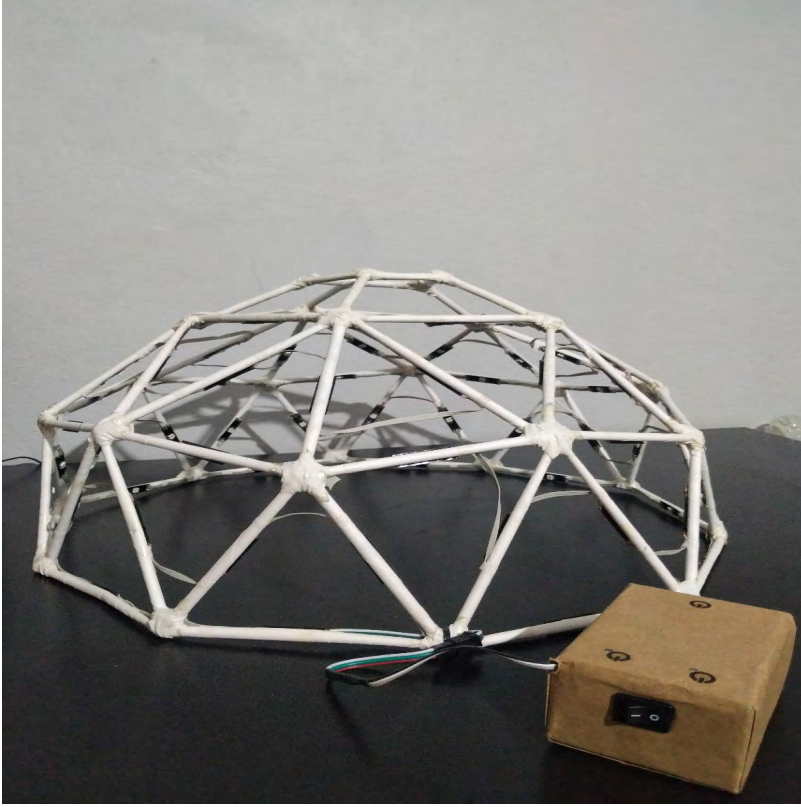
**Figure 10.** RTI dome in the geodesic structure. (Photo. Emirhan Çetinkaya)

The designed geodesic dome had two shooting modes. One of the two buttons on the dome's control was coded to trigger all LEDs, whereas the second button was coded to not trigger 10 LEDs close to the floor. The second button, which allowed shooting with 50 LEDs, was used to display three-dimensional subjects. Otherwise, an apparatus was needed to raise the dome. The color, light intensity, and light temperature can also be changed by coding the microcontroller. In this way, a more flexible working opportunity was created to emphasize the details of the object being imaged. The Bluetooth trigger in the hardware received commands from the Arduino UNO microcontroller. It was triggered 1 s after the smartphone camera started being illuminated by each LED. This allowed time for each photograph to allow the camera to receive sufficient light. The flashing times of the LED light sources during shooting and the trigger time of the Bluetooth module could be adapted to the exposure time. A 5-mm black ball earring with a glossy surface was used so that RTI algorithms could predict the direction of illumination. A 5-mm sphere was sufficient for a dome with a diameter of about 1 m. The angle of the reflections falling on the sphere could be recorded as an LP file. In this way, there was no need to use a sphere for each shot on the fixed equipment. Defining the LP file in the program while processing the images shortened the processing time.

The features of the hardware could be arranged according to the need through the software. Because it has an easy installation, it can be updated to shoot ultraviolet or infrared.
