# Current Approaches, Solutions and Practices in Conservation of Cultural Heritage

E-ISBN: 978-605-07-1592-7

DOI: 10.26650/B/AA9PS34.2024.006

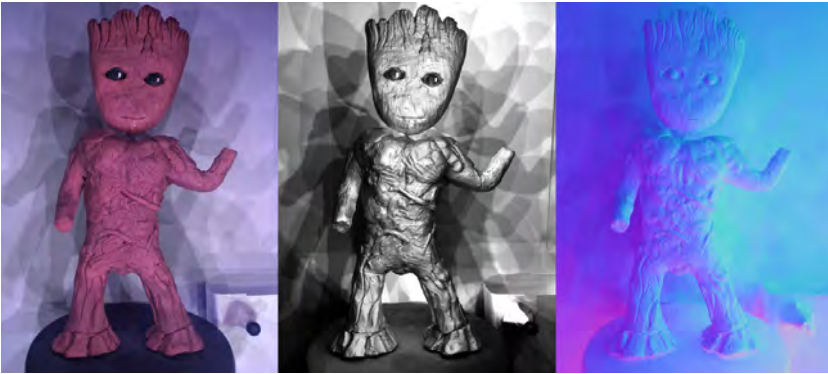
**Figure 11.** Ceramic object seen under flat light (left) and at the same light angle as the specular enhancement tool (medium) and normals visualization tool (right). (Photo. Emirhan Çetinkaya)

The handmade ceramic object in Figure 11 had a height of 12 cm. The RTI file of the ceramic object was created using a total of 50 photographs. In examinations made with color information, the details on the surface became visible at different light angles. The RTI image of the object gave information about the tools used and their angle of use and shape. At the same time, fingerprints could be seen in detail. The emphasis on detail could be replaced by the tools available to the RTI Viewer software. When the surface properties were examined with the specular enhancement tool without color information, the depth of the traces created by the instruments became clear. At the same time, the illusion created by glossy or matte areas was minimized. With the examinations, one fracture was seen in the arm and leg parts of the object. The lines on the legs were made with the help of a tool, and their depth differed from that of the fractures. The lines on the body had variable depths and angles. The tool depths show that about three different tools were used to make the object (Fig. 12). Fingerprints seen in areas where tool

marks were not dense show that these areas were shaped by hand. This recording of fingerprints by the RTI method could also contribute to the work of researchers working in this field. The method allows a qualitative examination of the object because it does not provide metric data and does not contain precision. However, with the data obtained about the details of the object, one can comment on the construction technique and the deformations it has undergone. On this basis, this method can be considered a safe method that can be used in due diligence in ceramic works that have already been repaired. In particular, it can be a useful method for comparing damages before restoration, the applications made during restoration, and the physical changes that occurred on the surface after restoration. Routine checks can also be observed with a fixed dome and camera parameters. Images can be obtained with embossed surfaces or written terracotta works with emphasis on the desired details.

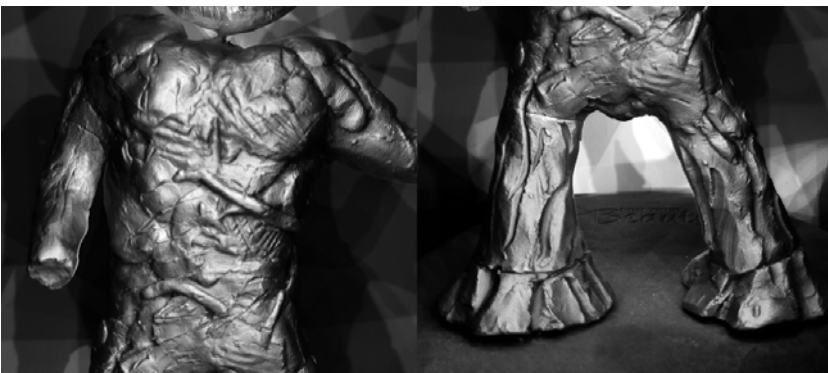
**Figure 12.** Detailed view of the ceramic object with the specular enhancement tool. (Photo. Emirhan Çetinkaya)

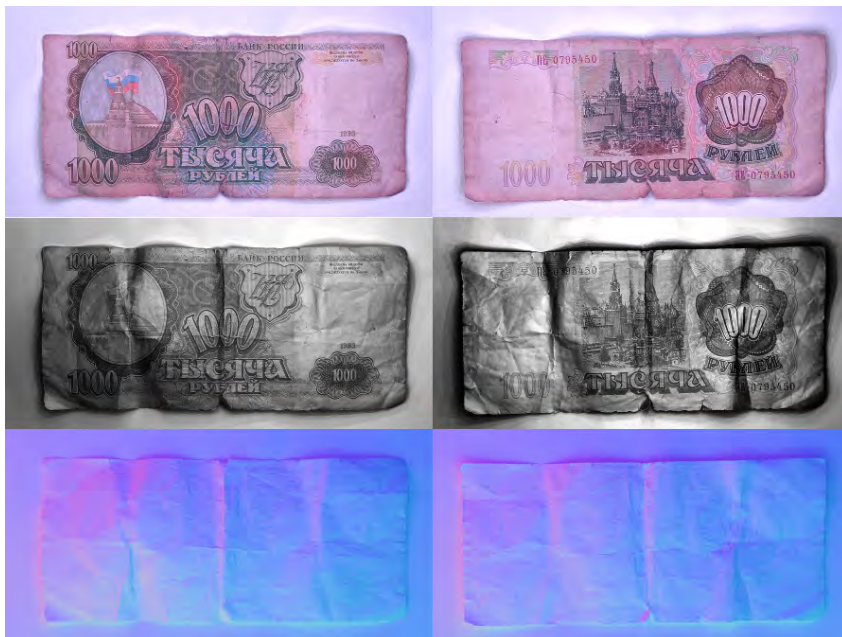
**Figure 13.** Appearance of the front and back of banknotes at the same light angle as the flat light (top), specular enhancement tool (middle), and normals visualization tool (bottom).

Two RTI files for the front and back of the banknote in Figure 13 were created by combining 60 images each. When examined with the naked eye, folding marks, tears, and some surface damage over time were noticeable on the surface. When the RTI image was examined, some tears were deeper and the folding marks were more than visible. In this way, details that may be overlooked during the determination of the methods and materials to be used in the repair of paper money were documented. Detecting damages on the paper surface made it possible to predict possible deterioration situations and implement preventive interventions. The physical damage caused by the areas with colored patterns and pictures on paper money was not clearly visible in the photographs. However, the specular enhancement tool included in the RTIViewer software allowed the surface to be examined without color information (Fig. 14). In this way, damage assessment images required for publication, exhibition, and documentation can be obtained. At the same time, the success of the intervention after repair applications can be documented with RTI images. In post-restoration controls, the physical results of the change that the works undergo under the influence of humidity and temperature in warehouse or exhibition conditions can be viewed using this method.

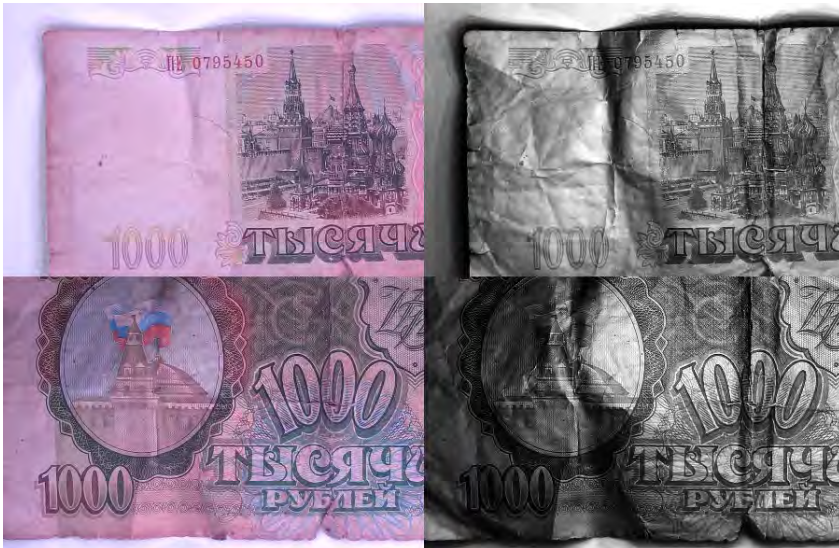
**Figure 14.** Detailed view of the front and back of a banknote in plain light (left) and with the specular enhancement tool (right). (Photo. Emirhan Çetinkaya)

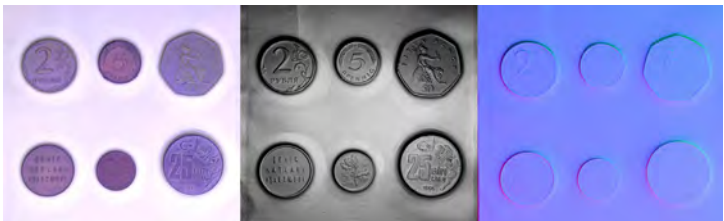
**Figure 16.** View of various coins in flat light (left) and at the same light angle as the specular enhancement tool (medium) and normals visualization tool (right). (Photo. Emirhan Çetinkaya)

To display the front and back sides of a stamp and coins in Figures 15 and 16, 50 photographs were used in the creation of the RTI file. Scratches on the surface of the coins were formed due to use. There were no mold marks as they were up-to-date materials. However, besides the traces on the stamp due to use, mold traces were also seen. These marks could be distinguished from the scratches that occurred later because they were more pronounced and deeper. Errors or marks on the mold gave information about the place of production of the coins and similar metal artifacts. Mold defects and marks on the surface of stamps can be examined together with a group of stamps of the same type and thus can provide information about their place and date of production. The surface of coin number 2 in Figure 17 shows distortion in the color images. However, when examined without color information, this deterioration did not cause any change in the surface. The physical change caused by the deterioration of the edges of coin number 1 on the surface can be clearly seen. When metal artifacts are photographed, detailed information about color change and corrosion cannot be stored. When viewed using the RTI method, the surface changes caused by corrosion can also be recorded. The extent of the damage in surface deterioration can also be monitored by this method. Thus, visual examinations using the RTI method are useful in limiting the cleaning on the surface of metal artifacts. This method can also be used to document the physical deterioration caused by different types of corrosion and to determine the intervention method.

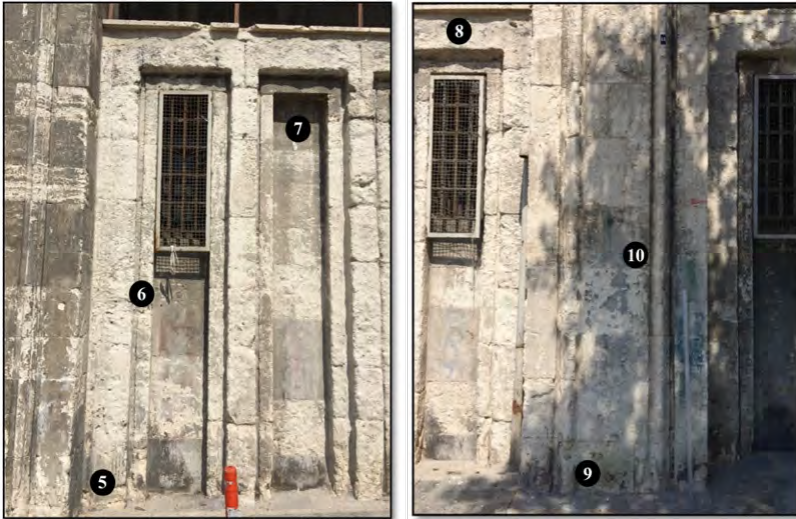
**Figure 3.** Numbering of the places to be sampled on the structure. Source: Emre Veysel ŞENER.

A total of 110 samples were taken from various parts of the studied facade, specifically areas where pollution has formed crusts, exhibit surface losses and erosion from chemical and atmospheric factors, and also from where stones are thought to be imitations. From the 110 samples collected, 48 were selected for investigation. The samples were numbered in the sequence 1, 2, 3, 4... from West to East along the South facade of the building (Figures 3 and 4).

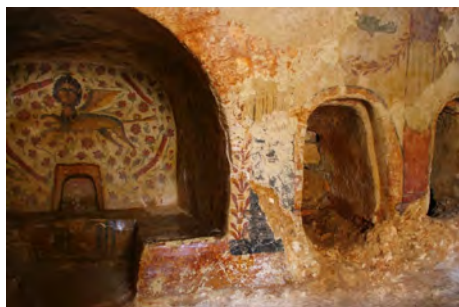
**Figure 1.** Tomb of the Veteran, 2nd century AD. This rock-cut tomb showcases two layers of rendering mortar, with the top layer featuring decorative elements. Som, H.K. of Jordan.

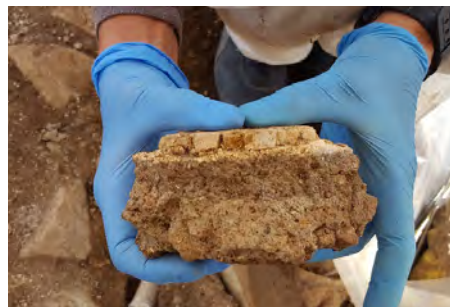
**Figure 2.** Mosaic fragment showcasing its layered structure, consisting of the following components: tessellatum, bedding layer, nucleus, and rudus.

Mortar-based heritage techniques have a stratified structure, showcasing the careful layering of materials (Fig.2). In certain cases, the rendering of structures may be reduced to a single layer of mortar that covers the underlying support. However, traditional and classic plastering techniques involve covering the substrate with several layers that overlap each other. This type of stratification is essential to ensure the desired mechanical qualities of the plaster once it dries, considering many environmental factors. The method described, which has a strong association with a longstanding tradition of historical texts and technical manuals, can be observed in several construction examples<sup>1</sup>. This technique has been used from classical antiquity to modern construction until the introduction of new industrial binding agents.

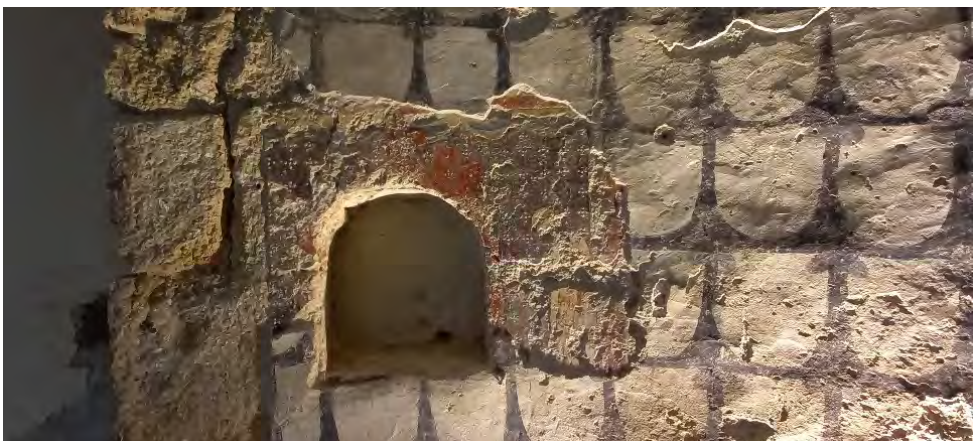
**Figure 3.** Concattedrale of Santa Maria Assunta in Venafrò (IS) displaying a palimpsest of fresco paintings from the 5<sup>th</sup>, 13<sup>th</sup>, and 15<sup>th</sup> centuries. The noticeable lack of adhesion between the renderings has resulted in significant loss and lacunae.

The solution of continuity between layers has always been an undesirable phenomenon, which can lead to a progressive process of decay. The causes leading to the separation between originally adjacent and adherent rendering layers are several and synergistic (Figure 3-6). Sometimes, the presence of adhesion defects between layers can be attributed to intrinsic causes. Faults in execution can occur at the origin: too dry support or underlay, excessive ventilation during the setting and curing phases, and curing under conditions of poor carbon dioxide availability can all predispose to subsequent conservation problems. These conditions can cause the so-called *shrinkage* phenomenon: a sudden decrease in the volume of the mass, resulting in localized stresses that form cracks and detachments in all directions. This type of phenomenon often takes the form of delamination between different layers of renderings or separation from the support. It can follow the texture of the support underneath, e.g., lacking of adhesion in correspondence with mural joints or wooden or stone elements (Quagliarini et al., 2011).

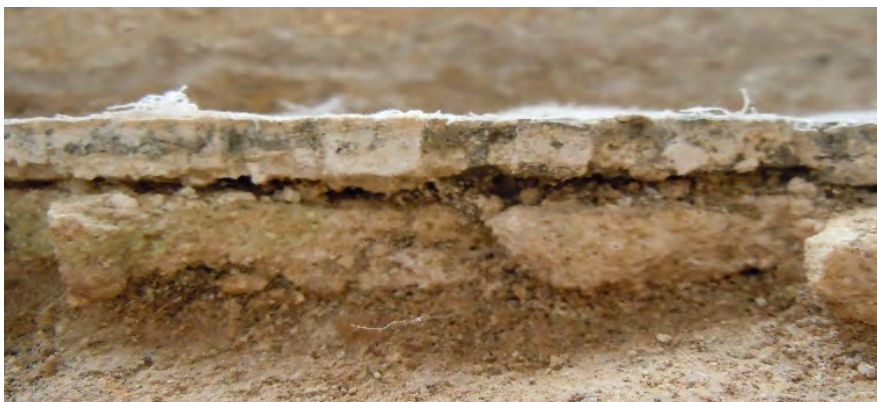
**Figure 4.** In situ detachment of the tessellatum and its bedding layer from the nucleus.

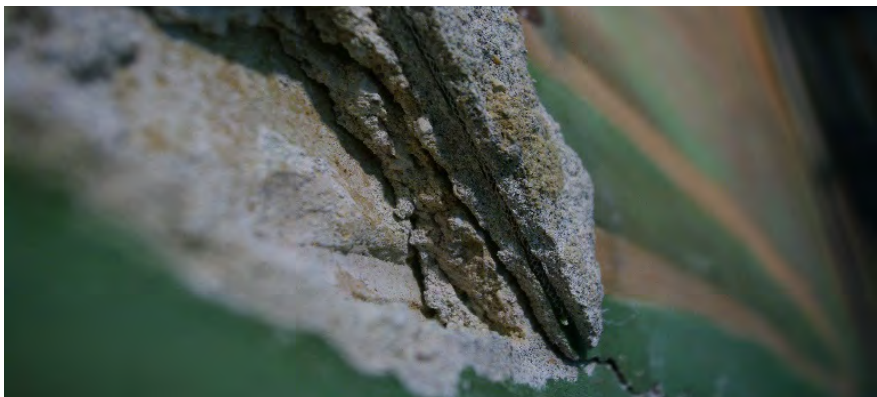
**Figure 5.** In situ delamination and detachment between preparatory layers due to shrinkage. Museo delle Arti e Tradizioni Popolari, EUR, Rome.

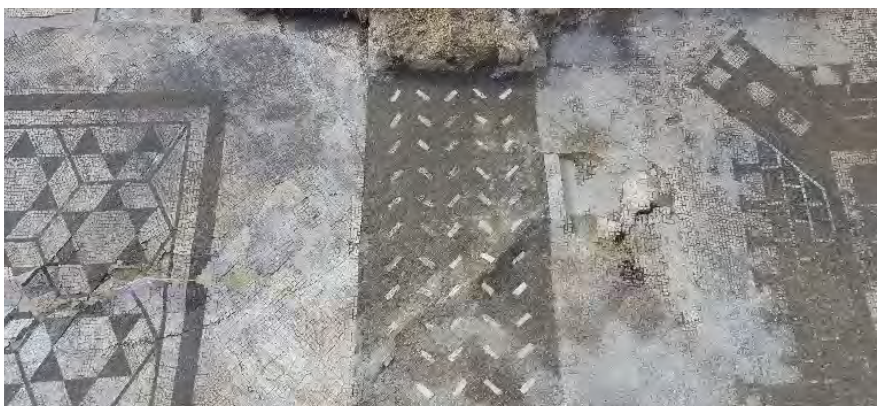
**Figure 6.** Bulges and rise of the tessellatum due to environmental causes. Archaeological site of Carsulae, Terni, Italy.

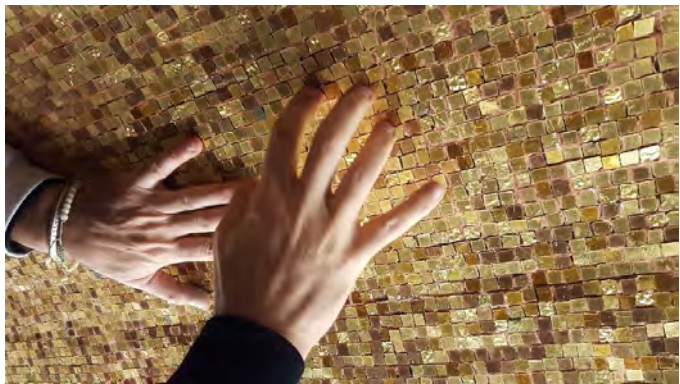
**Figure 7.** Auscultation by tapping with the fingertips.

The auscultation test is performed by maintaining contact with the entire rendering surface. The restorer, focusing on categories such as “detachment,” “lack of adhesion from the support,” and “deformation of preparatory layers,” aims to discern the distribution, extent, and sometimes the nature of the defect (including whether it affects superficial or deep layers and whether it involves debris accumulation or voids).

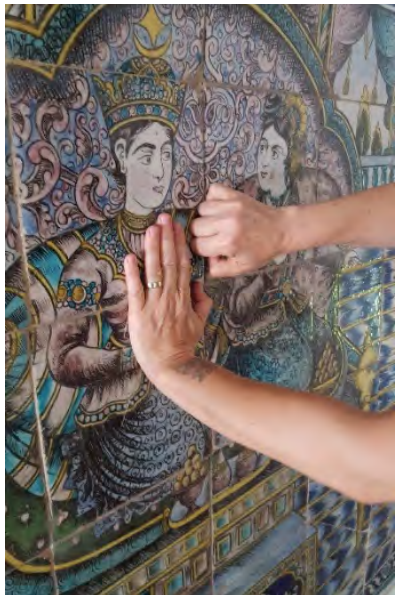
**Figure 8.** Auscultation by knocking.

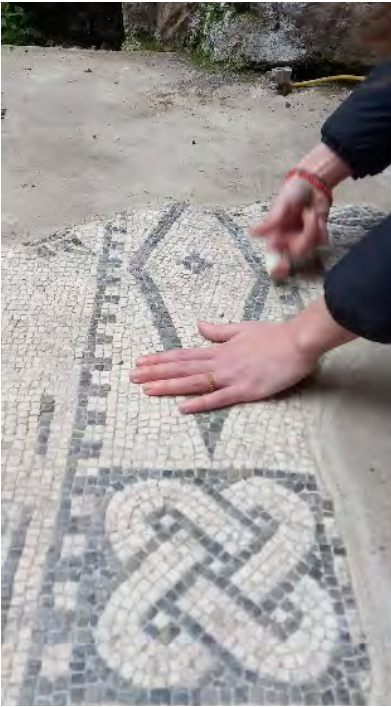
**Figure 12.** Auscultation.

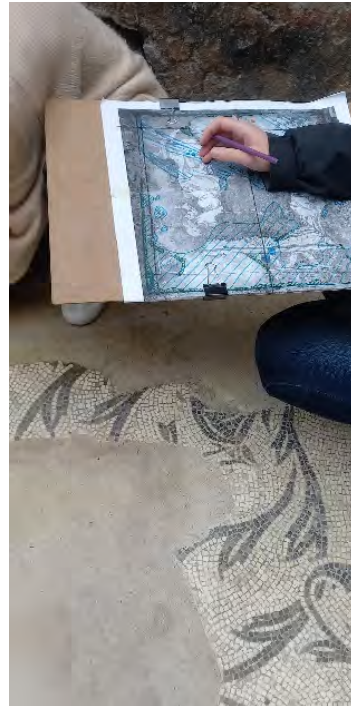
**Figure 13.** Transfer of information to another operator for drawing on the documentation.

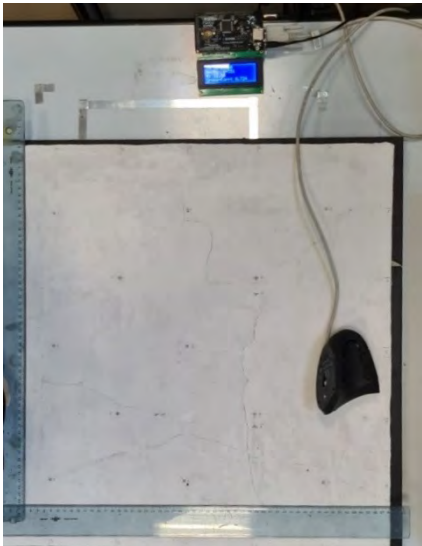
The hardware apparatus of the PICUS system is composed of a probe equipped with a miniaturized electromechanical percussion element (a solenoid), a microphone, and an infrared (IR) camera, all connected to a low-cost Arduino-like microcontroller, as shown in Figg. 14 and 15. Furthermore, because the probe's position in the measurement scenario is important, a two-dimensional measurement system based on the use of an IR camera that detects the location of an IR-LED placed on the probe is implemented (Caliano et al., 2021).

**Figure 14.** PICUS microcontroller and probe.

When the operator performing the procedure presses a button on the probe case, the microcontroller actuates the solenoid core to gently tap the surface under test. The force applied can be regulated according to the need. The microphone allows the capture of the free-vibration audio signal generated by the impact of the solenoid nucleus on the surface. The IR camera sends the  $X$  and  $Y$  coordinates of the IR-LED on the probe to the microcontroller unit to provide the localization of its position on the plane, (Fig. 16).

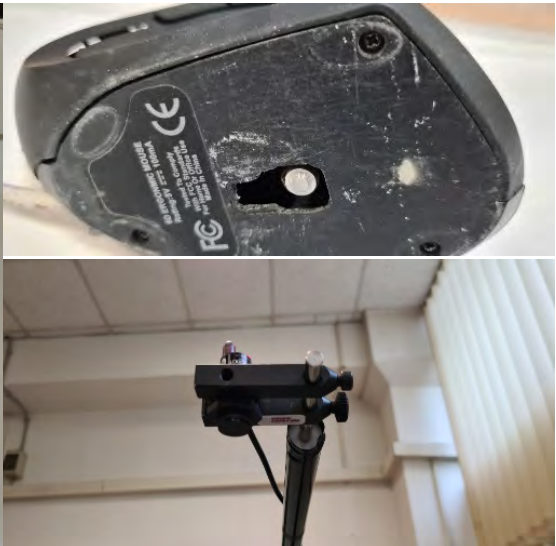
**Figure 15.** (top) PICUS probe mounted on a mouse-case; (bottom) PICUS IR camera.

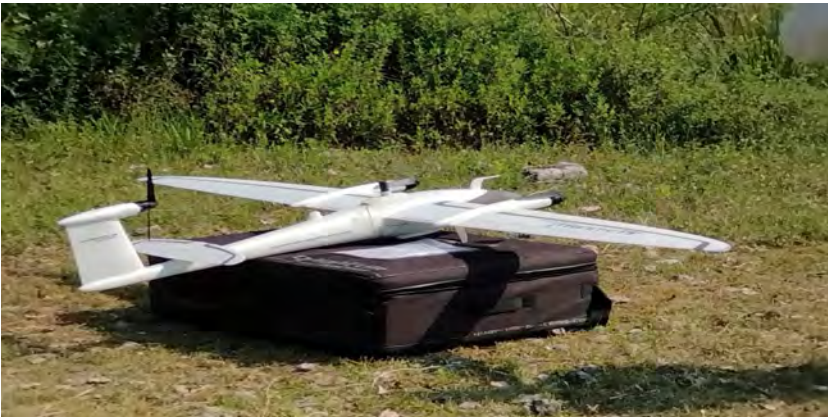
Given the time constraints (i.e., only 5 days were available), covering the entire 38,000 square metre park area was impossible. The chosen technology was LiDAR, mounted on the Trinity +90 fixed-wing drone (Fig. 3).

**Figure 3.** VTOL Trinity+90 ready for the survey.

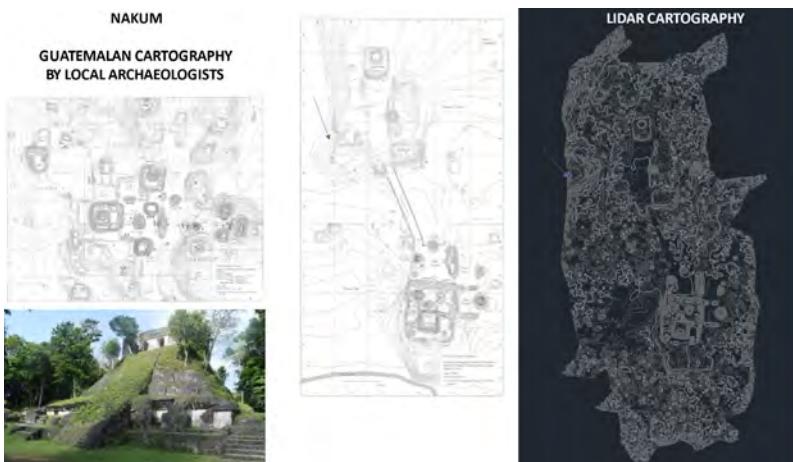
By comparing the cartographies that derive from the results achieved, with those of local archaeologists who have been on-site in the past and have published their results (Fig. 17), we report how our topography is accurate and precise, just as the georeferencing is precise, notably in contrast to the sources analyzed before the survey. This is a practical result from which the scientific community will undoubtedly benefit, as a more rigorous and higher-quality basis for study. Returning to the work, from an individual point of view, the study of the micro-topographies, the tumuli between one pyramid and another, is noteworthy and helps us to configure the spaces better, also giving proposals and suggestions for different kinds of users. What do these tumuli consist of? Can they constitute valid additional research for spatial pattern analysis? If applicable, do these spatial patterns indicate planning activities beyond the monumental core of the Pyramids? Otherwise, in what areas of archaeology can they demonstrate progress? How might these sites be properly investigated in the future? (Fig. 18).

**Figure 17.** Nakum cartography by previous archaeologists and by LiDAR survey.

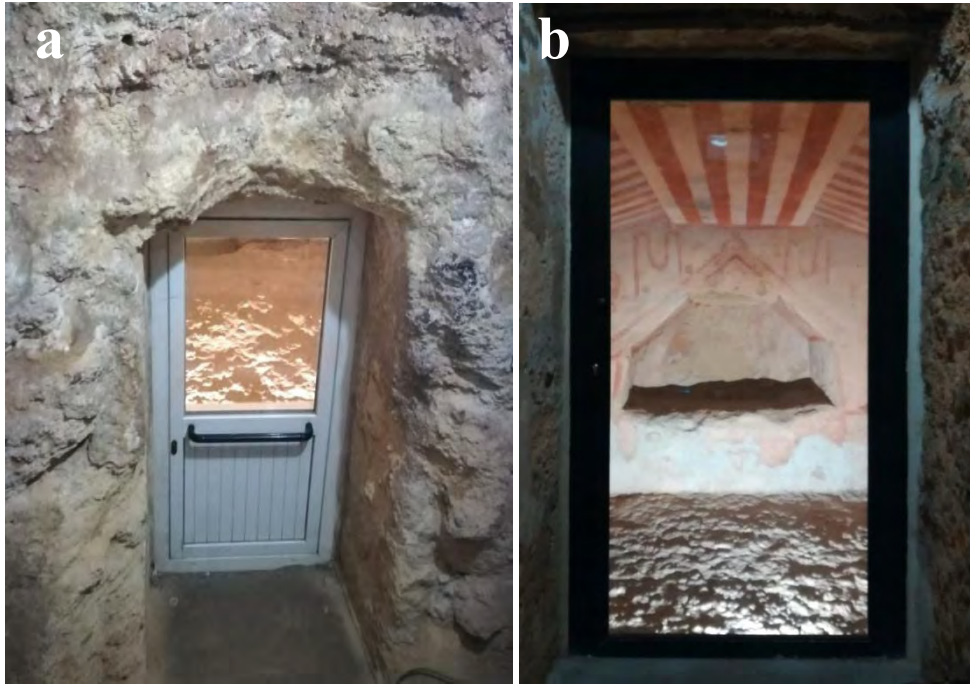
**Figure 2.** Examples of thermally insulating doors: earliest prototypes installed (a) most recent type (b): equipped with full glass.

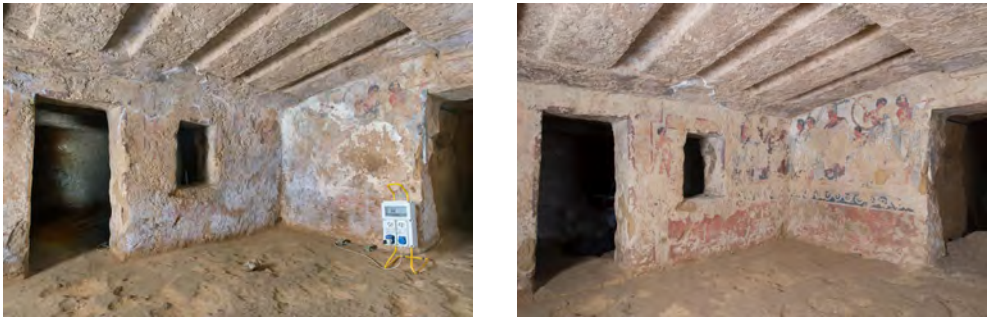
**Figure 3.** *Tomba degli Scudi*. South-east walls: before restoration (left) and after restoration (right).

The restoration endeavor was initiated in June 2016. Spearheaded by the *Soprintendenza Archeologia, Belle Arti e Paesaggio per l'Area metropolitana di Roma, la provincia di Viterbo e l'Etruria meridionale* (the Office of the Ministry of Culture in charge for the protection and management of the site before the creation of the Archaeological Park) with a valuable contribution from the FAI (*Fondo Ambiente Italiano*), promoted the restoration of the walls in the *atrium* of the tomb (Fig. 3).

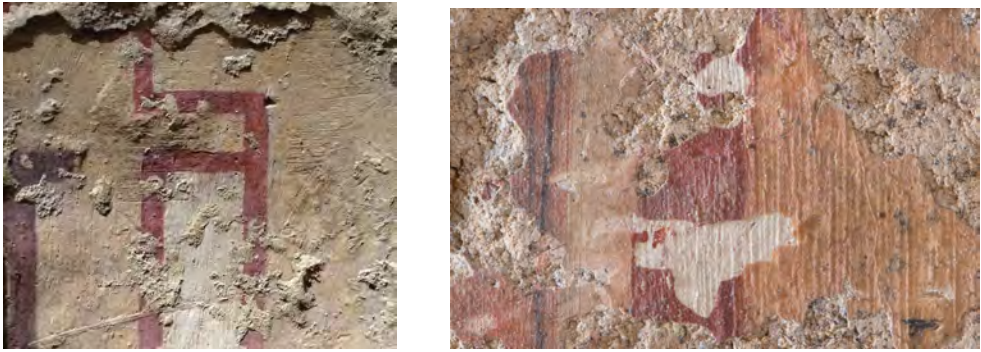
**Figure 9.** Left: *Atrium*, the brushstrokes of the whitewash and the pictorial layer are well-visible under raking light. Right: detail of the same wall.

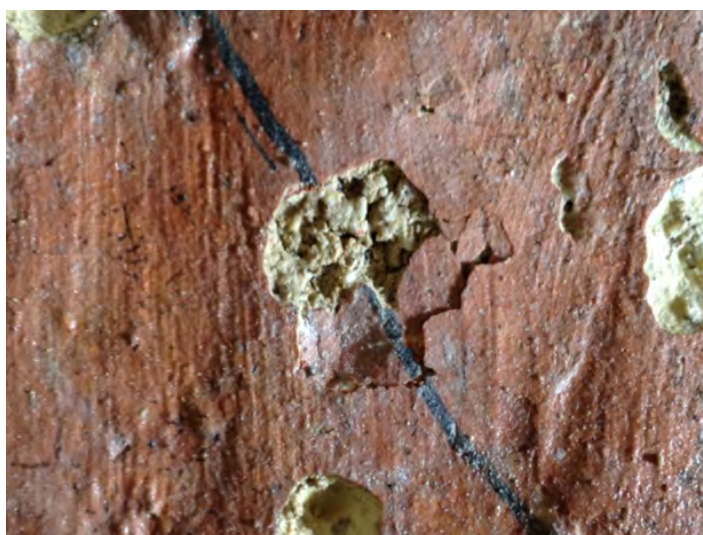
**Figure 10.** *Atrium*, voids of different sizes are present underneath the pictorial layer.

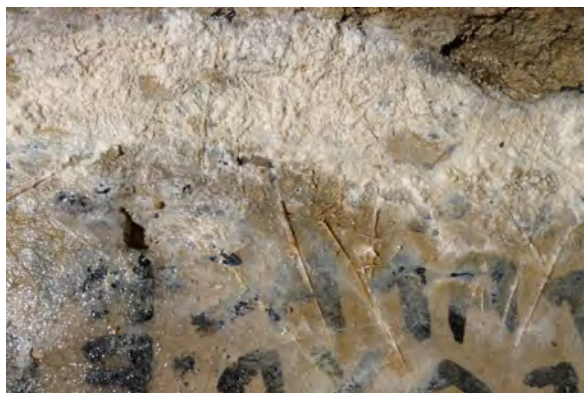
The outlined reaction demonstrates that  $\text{CO}_2$  molecules, upon interaction with water, undergo a transformation into carbonic acid ( $\text{H}_2\text{CO}_3$ ). Subsequently, the dissociation of this acid releases  $\text{HCO}_3^-$  and  $\text{H}^+$  ions. These ions react with the dissolved calcium carbonate, yielding bicarbonate and calcium ions. Intriguingly, this reaction is reversible: following the acid-mediated dissolution of calcium carbonate into bicarbonate that is soluble, and therefore, readily removed by infiltrating water, the calcium carbonate may be precipitated from the solution. Nonetheless, this precipitation process is gradual and contingent on specific environmental prerequisites (Lerman & Mackenzie, 2018). Consequently, within the tomb, the plaster acts as the nexus for this chemical dynamic, resulting in a substantial reduction of calcium carbonate within the layer structure, and consequently, the loss of extensive painting sections. Calcite deposition may materialize as either insoluble patinas or dense concretions (Fig. 11).

**Figure 11.** *Atrium*, carbonate depositions of different nature and typology are re-deposited on the pictorial layer.

The patina, characterized by its glassy and pale appearance, served a protective role for the painted layer in the *atrium*. Nevertheless, it induced a slight tonal lightening and, in certain instances, exhibited flaking that compromised part of its depth. Ultraviolet fluorescence (UVF) imaging conducted during the restoration phase indicated that these deposits aligned with regions exhibiting pronounced fluorescence (refer to Chapter 5). Although visually, these zones appeared unaffected, tactile examination revealed pronounced dampness. Hypothetically, these damp zones might harbor water enriched with  $\text{CaCO}_3$  or other compounds conducive to surface carbonate precipitation.

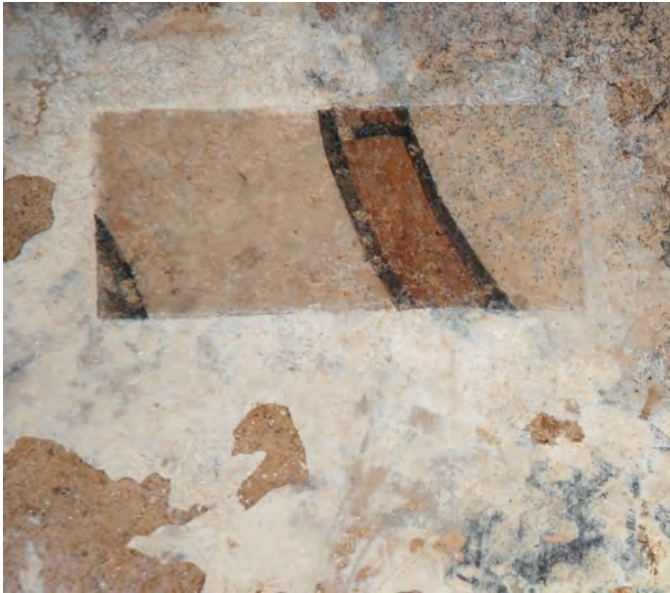
**Figure 13.** Detail of the biological patina of moonmilk, where it is thicker and harder, thereby protecting rather than damaging the murals.

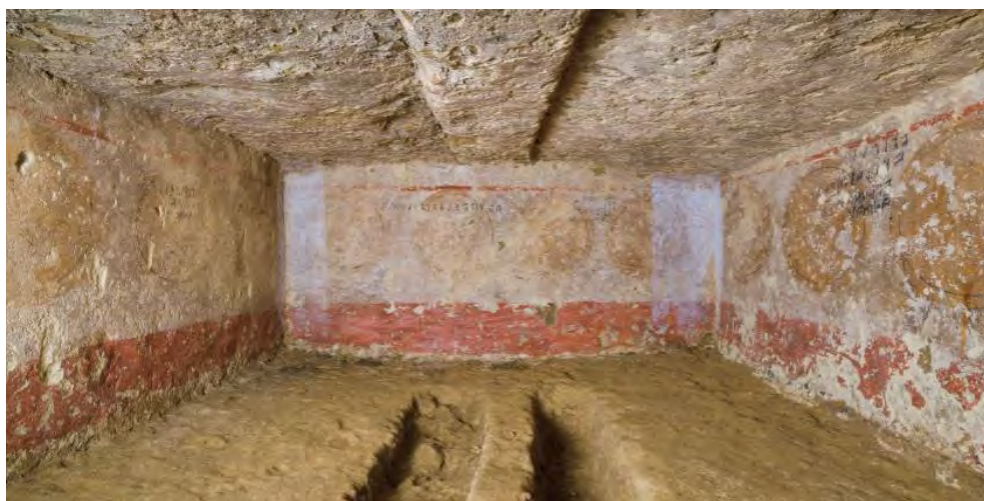
*Burial chamber: Pre-restoration.* Throughout the restoration, professionals noticed an unusual white deposition on the tomb walls and ceiling. The wall paintings were obscured by a white, feathery carbonate layer, a calcite deposit known as moonmilk (Mura et al., 2020). Commonly found in karst caves, moonmilk is composed of calcite nanofibers, each less than 1  $\mu\text{m}$  in width (Fig. 14) (Mura et al., 2021).

**Figure 14.** Burial chamber after the restoration. Two microbiological samples for each wall were studied.

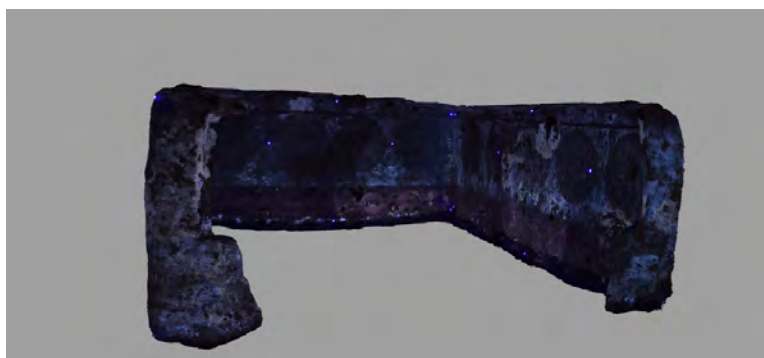
**Figure 21.** View of 3D model of *Tomba degli Scudi*, with white targets visible.

model, we acquired 30 photograms subsequently processed through Agisoft Metashape®. This software facilitates photogrammetric processing of digital visuals, including aerial and close-range imagery, to produce 3D spatial data coupled with high-definition photorealistic rendering. Employing a comprehensive Structure from Motion (SfM) method, the software merges digital photogrammetry with advanced computer vision capabilities [Lowe, 2004]. This culminated in the creation of a 3D photorealistic model of the tomb, with an illustrative view presented in Figure 21. An interactive model can be accessed *via* this link: <https://sketchfab.com/3d-models/tomba-degli-scudi-tarquinia-7a183dcbe1e84bb199babcc0b30c3905>

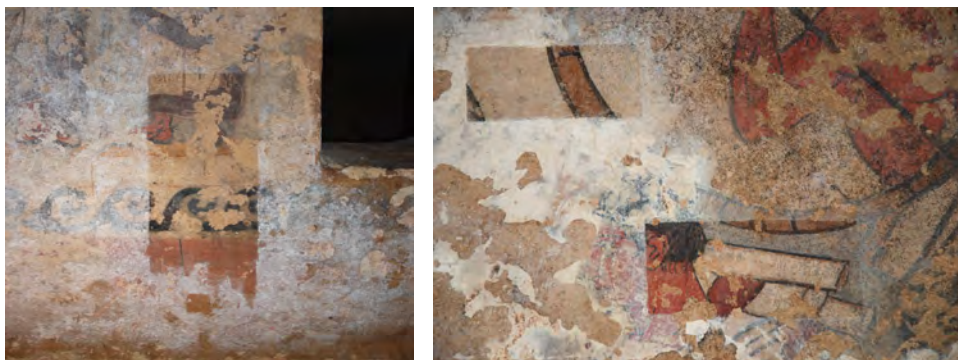
For eliminating moonmilk patina, a 1% benzalkonium chloride water solution was chosen. Application was done using a gentle synthetic bristle brush, with minimal agitation to the surface to lift the patina that rendered the surfaces coarse. In areas where the conservation state permitted comprehensive cleaning, residual moonmilk deposits were eradicated using

low-pressure nebulizers and soft sponges, methodically dissolving and blotting the sediment. Supported by the biocidal properties of benzalkonium chloride, the subtle surfactant potential of the product chemical composition aided in dispelling the patina, mitigating prolonged interaction with the fragile plaster and pictorial layer substrates (Figs. 23 and 24).

**Figure 23.** Cleaning tests with the removal of calcite depositions. (Left) north-west wall and (right) south-east wall of the tomb.

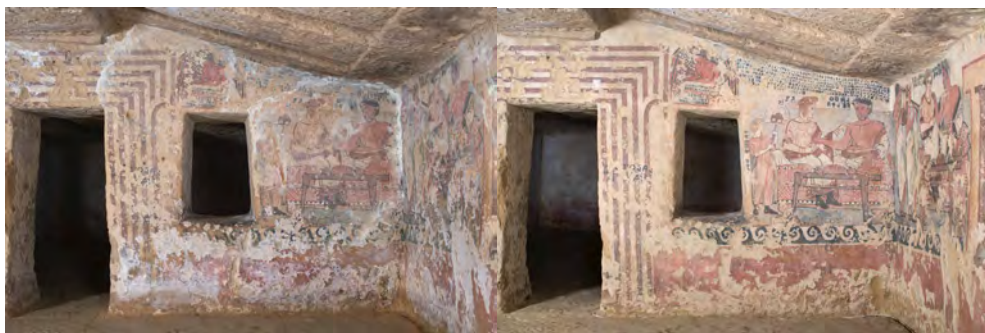
**Figure 24.** North-east walls before (below) and after restoration (above).

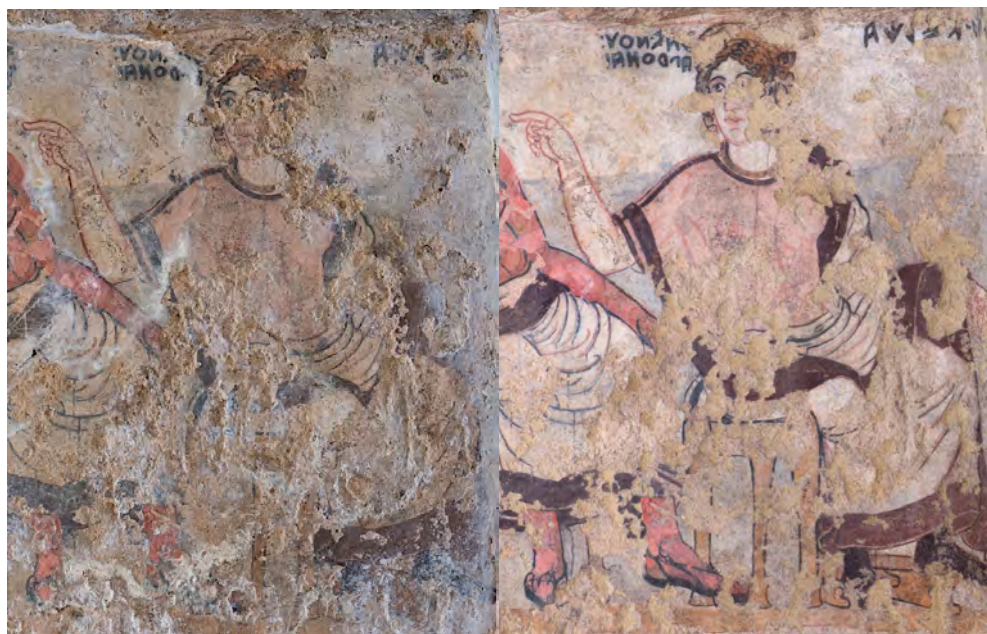
**Figure 25.** *Ravnthu Aprtnai* on the South-West wall. The deeper losses of the plaster have been partially infilled for conservation reasons and to make the image easier to read. They were then glazed with natural inorganic pigments to have a single tone of that level.

On the foundational level, which comprises the fragile sandstone support known as *sabbione*, only the edges of significant and deep gaps were stabilized, primarily for conservation reasons. These minimal infillings were crafted using yellow sand, closely resembling the original in both color and grain size, and bound with a sparse amount of a 1:6 water-diluted colloidal silica solution. This high dilution of the binder produced a mortar that was both malleable and of low mechanical strength, reflecting the properties of the original material. This level was maintained incomplete was backed by the intent to preserve the historical integrity and state of the artwork, especially considering the overall deterioration of the paintings and the specific origins of these gaps. Notably, a number of these gaps can be traced back to distinct, documented historical events. The upper plaster layer saw only selective infillings, corresponding to its original elevation (Fig. 25). Although the *sottolivello unico* technique (entailing the unification of all infilling levels of a layer—wall, *arriccio*, plaster, *intonachino*, etc.—to a singular elevation for distinction from other layers) is commonly employed for wall paintings, it was deemed unsuitable here. Such a method would have substantially altered the visual representation of the artwork conservation status. Following the infilling of the preparatory layers, an initial surface assessment facilitated decisions regarding pictorial reintegration. Primarily, the tone of minute gaps and abrasions in the paint film was subdued. The light hue of both the original and filled plaster made the gaps more prominent than the actual painted images. To prevent the lacunae from drawing undue attention, their tone was slightly reduced, referencing specific areas where the plaster naturally appeared darker. Only stable, water-diluted powder pigments were employed for pictorial touch-ups. The decision to forego water colors or other conservation-specific colors was established during the initial 2016 restorations, to exclude any organic material, such as Arabic gum, which could potentially serve as a habitat for microbial colonization. Additionally, an additional binder is not required given the porous nature of plaster.

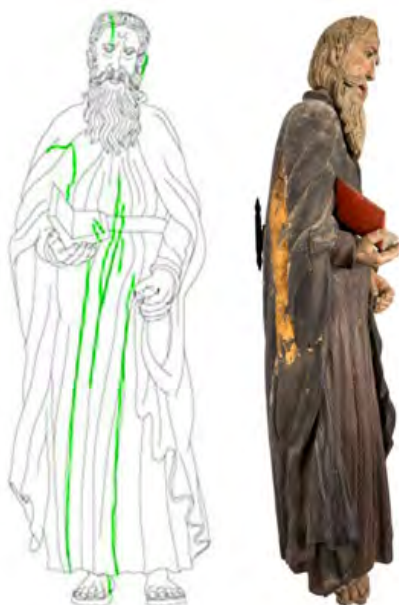
**Figures 1 and 2.** Representation of the fissures of the front and photograph of the partial lacunae of the back.

The points of degradation, which motivated the choice of this object for study on application of recycled cork, included the important fissures that the sculpture has both on the front and on the back and the partial gap induced by the action of xylophagous insects on the aforementioned element positioned on the back near the right shoulder.

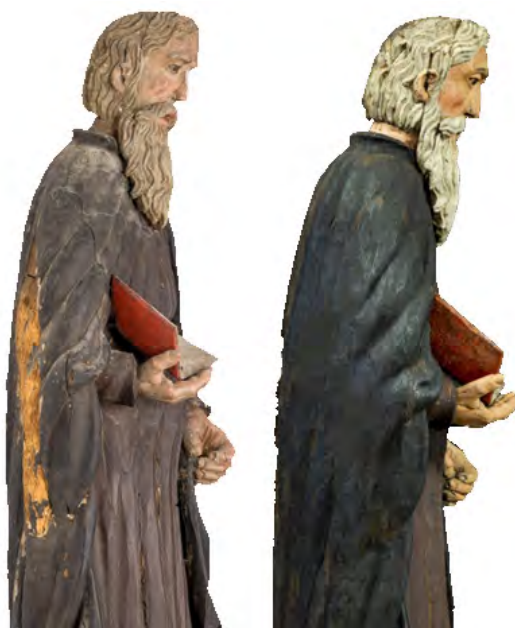
**Figures 4 and 5.** The sculptor before and after restoration. The structural rehabilitation of the portion degraded by xylophagous insects carried out with recycled cork plaster is also visible.

The gap on the back, because of its extension, was restored in the upper part through a double-level tessellation performed with recycled corks and glued with polyvinyl acetate. The lower part, previously consolidated, was grouted with a compound comprising one part of thick filler (2–3 mm), two parts of medium filler (1 mm), and one part of fine filler (<0.5 mm) bonded with the same binder as the previous one.

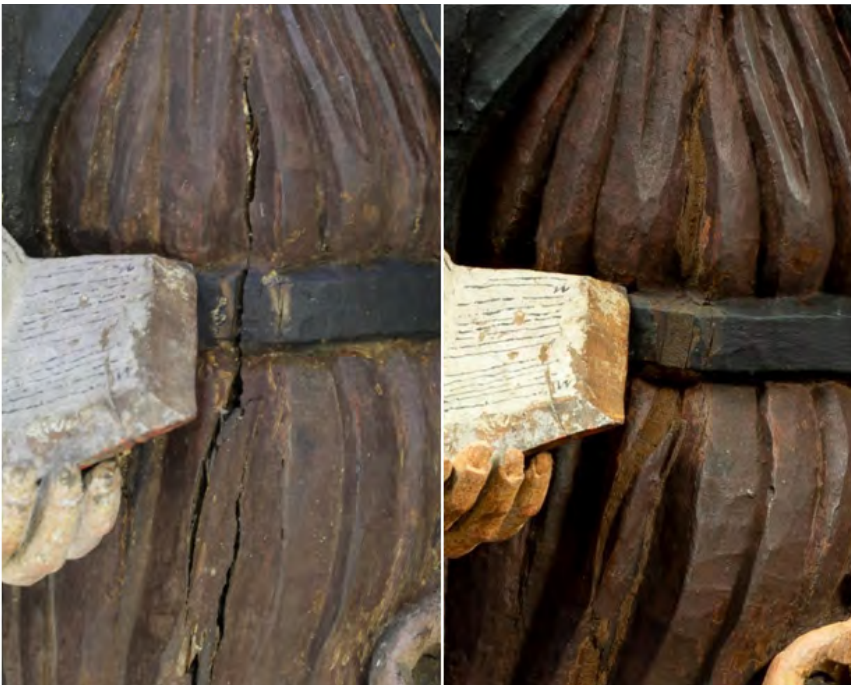
**Figures 6 and 7.** Fissures before and after plugging with cork stoppers.

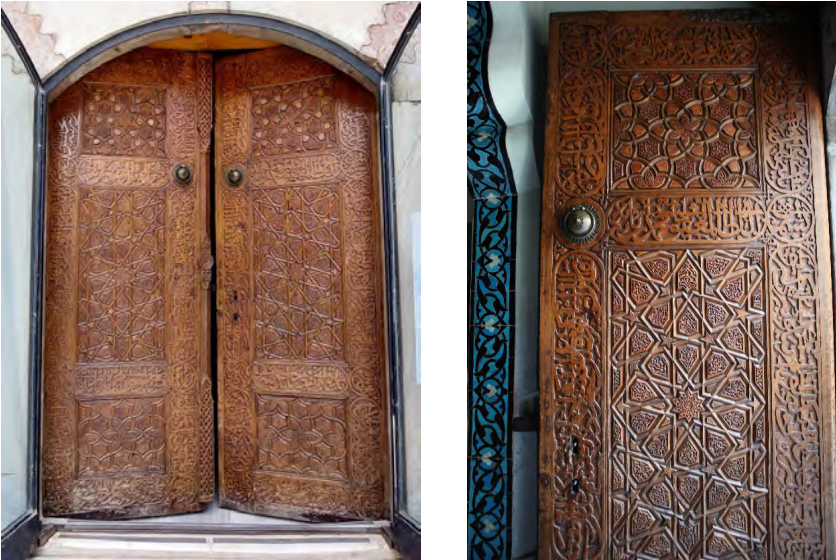
**Figure 1.** Door wings of Bursa Green Tomb (Photo. I. Özsaıt-Kocabaş).

curved laths on the upper and lower panels of the door wings. The stiles and rails of the door are decorated with Seljuk thuluth and Kufic (Figure 1). Its astragal is decorated with fish scale motifs (Demiriz, 1979, p. 397). The door wings of Suleyman the Magnificent Tomb, dated in the 16th century, are made of walnut wood, made with the original kundakari technique decorated with the mother-of-pearl, ivory, and bone inlays (Figure 2). The wooden window shutters in the lower row at the tomb were made of walnut wood with the kundakari technique (Ziyrek, 2011, p. 127) (Figure 3). The walnut doors of the 16th century Süleymaniye Mosque, made with the original kundakari technique, consist of ten-armed stars and protruding medallion compositions. Thin wood fillets are engraved on the backs of the laths that make up the geometric grid. The astragal on the main door wings of the mosque is covered with ebony and decorated with vegetal motif ivory partitions and ebony inlays. The inscription on the top panel of the main door wings of the Sultan Ahmet Mosque, dated the 17th century, is constituted in mother-of-pearl inlaid letters on the tortoiseshell background. The middle panel is formed with a ten-armed star kundekari composition and ivory sticks on geometric partitions, an ebony tree on some small pieces, and mother-of-pearl plate inlays are used on large-surfaced blocks. The last traces of this technique were evident at the beginning of the 20th century on the door wings of the Topkapı Palace Cardigan-i Saadet Office. The surface of the door wings, formed by covering the inscription on the upper panels and ten-armed star compositions on the middle and lower panels with mother-of-pearl, tortoiseshell ivory, and ebony, are decorated (Avunduk, 1996, pp. 61-64).

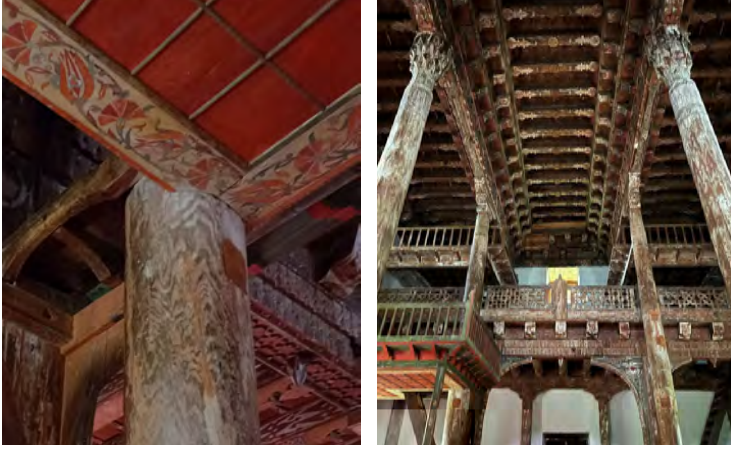
**Figure 7.** Wooden members decorated hand-painting in the Mahmut Bey Mosque, wood columned and wood roofed (Photo. S. U. Olcay, F. Yılmaz).

The pillars, column heads, muqarnas, consoles, beams, and ceilings of wooden pole mosques in Anatolia from the 13th century to the present are decorated with colored hand painting (Figure 7). This technique was developed during the Ottoman period and primarily applied in 15th and 16th-century religious architectural members, such as mahfil ceilings, and in civil architecture, ceiling, cabinet doors, and doors (Kantarcioğlu, 1992; Ersoy, 1993, p. 52). In this method, multi-colored decorations with geometric and floral motifs with red, yellow, blue, white, and black root dyes (Akok, 1946; Aslanapa, 1989, pp. 130-135). In addition, to this technique, the Edirnekari technique, which emerged in Edirne, was used in Ottoman wood decoration between the 14th and 19th centuries. Edirnekari was applied in old Turkish houses, palaces, and mosques, wooden elements such as balusters, window sashes, cabinets, and their doors, writing drawers, chests, minbars, and ceiling on floors decorated with carvings or inornate (Türkoğlu, 1967, p. 68).

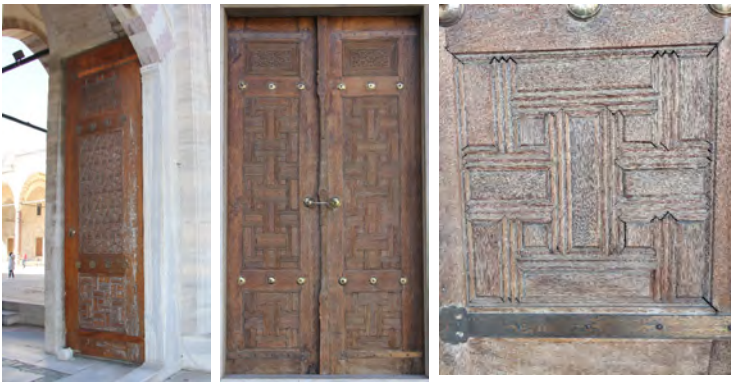
**Figure 8.** Loosening between wooden fragments, weathering, and discoloration on the mosque courtyard door wings (Photo. I. Özsaıt-Kocabaş).

Wood is a material that exhibits minor deterioration under suitable conditions. The deterioration rate varies depending on the type of wood, its environmental conditions, and the severity and duration of exposure to the disruptive factor. Many wooden artifacts inside buildings have remained intact and usable for centuries in dry environments. By contrast, wooden artifacts in outdoor areas can exhibit damage because of atmospheric effects and environmental factors. Due to atmospheric effects, rain and wind load, sand and dust particles carried by the wind, mechanical wear, surface losses, and roughness can occur in wooden artifacts (Figure 8). Increased aging, cracking, color changes, and grays out over time are observed due to combustion and solar radiation caused by the oxidation of the air (Unger et al., 2001, p. 47).

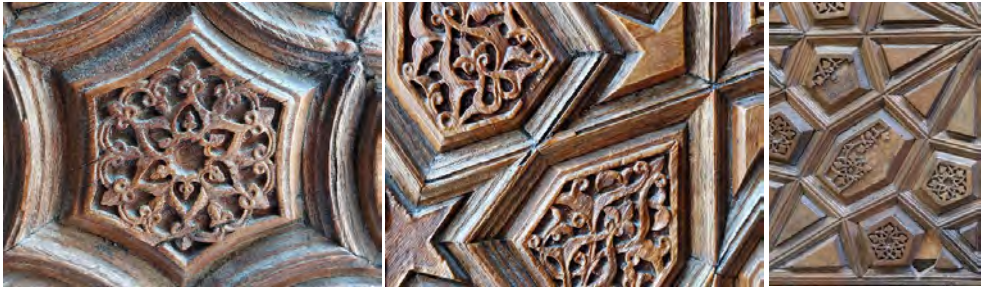
**Figure 9.** Wearing, breaking, and falling on the surfaces and inlay materials of decoration motifs (Photo. I.Özsait-Kocabaş).

occur. In carved artifacts of solid wood, longitudinal cracks and splits occur due to internal stresses. Detachments, fragmentation, and disintegration are observed in carved motifs (Öney, 1970, p.139). Furthermore, in the wooden members in the architecture, incorrect usage, insufficient protection, and uncontrolled factors in the cleaning and maintenance can create a deteriorating effect as much as the ambient conditions. Formal deformations caused by mechanical aging in elements such as door wings, losses in surface and cross-sections, and wearing, scratching, superficial lifting, and breaking of the ornament and polish layers are among the most common damages.

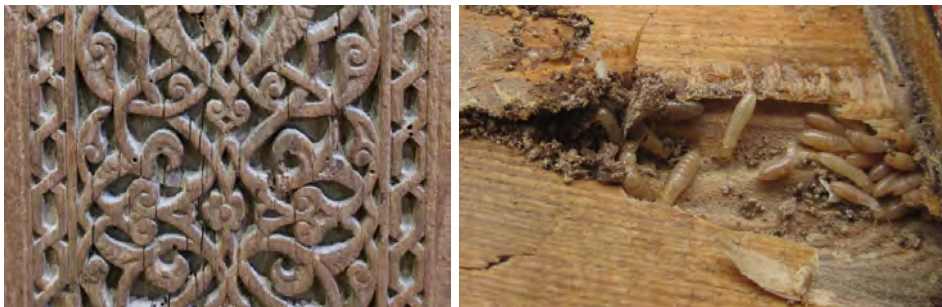
**Figure 10.** Longitudinal cracks and insect's exit holes on the decorated surface (left); termites in the window frame (right) (Photo. I. Özsait-Kocabaş).

Insects use wood as a food source, shelter, and egg-laying area. *Hylotrupes bajulus* (house longhorn beetle), *Xestobium rufovillosum* (death watch beetle), *Anobium punctatum* (common furniture beetle), *Ptilinus pectinicornis* (fan-bearing wood-borer), and *Lyctus brunneus* (brown powder post beetle) are the most common insects that directly damage furniture, artworks, historic woods, door and window joinery, and painting frames (Unger, 2001, pp. 56-57; Ünal et al., 2009). Insects undergo complete transformation throughout their lives and undergo metamorphosis, encompassing four developmental stages, namely egg, larva, pupa, and adult. The feeding activity of the larvae causes primary damage to the wood. The greater the activity time and number of galleries are in the timber, the greater is the destruction. The exit holes the adult insect opens are less damaged than the larval stage. Deterioration occurs when the starch, sugar, protein, and cellulose in wood are used for nutrition, and the cell wall is destroyed (Toper-Kaygın & Sade, 2004). Termites are essential wood-destroying insects. The lamellae of latewood remain as support; the earlywood layer turns into dust (Figure 10). Because the outer surface of the wooden element always remains intact, the internal damage cannot be observed from the outside until the inside of wood completely crumbles. This phenomenon causes sudden collapses and severe damage to wooden structures (Unger et al., 2001, p. 76).

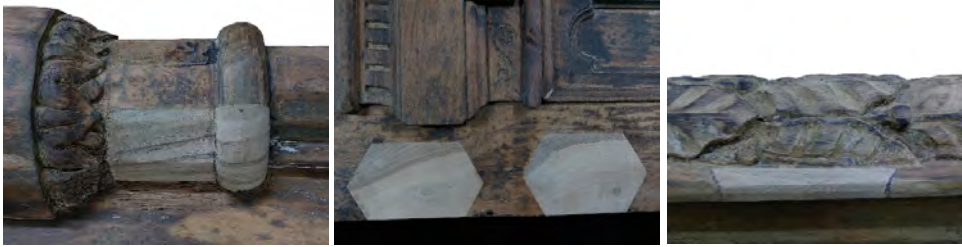
**Figure 13.** Partial repair with new wood (Photo. I. Özsaıt-Kocabaş)

The principle in the restoration of woods with historical and cultural value is to improve the current condition of the artifact and ensure its existence in the future with its original identity. The restoration grade is essential. Unnecessary intervention and aesthetic corrections to will change the originality of the artifact should not be made. During the applications, the ornaments and the brittle varnish layer on the surface should be protected as much as possible. The degree of interference to the original surface layers, integration of the carvings, inlays, and paint decorations, and completion of missing parts with new materials should be determined individually for each artifact according to its characteristics and where it will be placed after treatment. For example, stopping deterioration and consolidating artifacts stored under controlled environmental conditions in museums may be sufficient. By contrast, more robust and protective conservation methods and measures should be considered for wood in architecture with open spaces, high visitor numbers, and unstable environmental conditions. Increasing the structural strength, extra precautions against touching, pushing, and impact at the places of use, atmospheric effects, and surface treatments that will provide resistance against wetting must be considered. Removing rotten parts that have lost their strength and ability to carry themselves and replacing them with new wood is an unacceptable approach in archaeological and artistic artifacts. However, in the context of historical architecture's sustainability, the decaying parts of the damaged bearing wooden elements can be replaced with new parts for the structure to survive, which is consistent of the necessary permits (Ahunbay, 2019, pp. 237-238). However, the use of new wooden pieces in the historic wooden architecture increases with each repair as rotten parts are removed. With the progress of this situation, the original materials and construction techniques disappear, and the wooden elements risk losing their historical document quality. Therefore, the original wood pieces must be preserved as much as possible; in case of partial damage, only the rotting parts should be scraped instead of replacing the whole piece, adding new wood only to the necessary parts

(Figure 13). Subjects, including replacing old wood with new wood, completing missing parts with synthetic resins, the rate of these applications, and the extent to which the additions and repairs are noticed from the outside, have different opinions of restorators.
