# Current Approaches, Solutions and Practices in Conservation of Cultural Heritage

E-ISBN: 978-605-07-1592-7

DOI: 10.26650/B/AA9PS34.2024.006

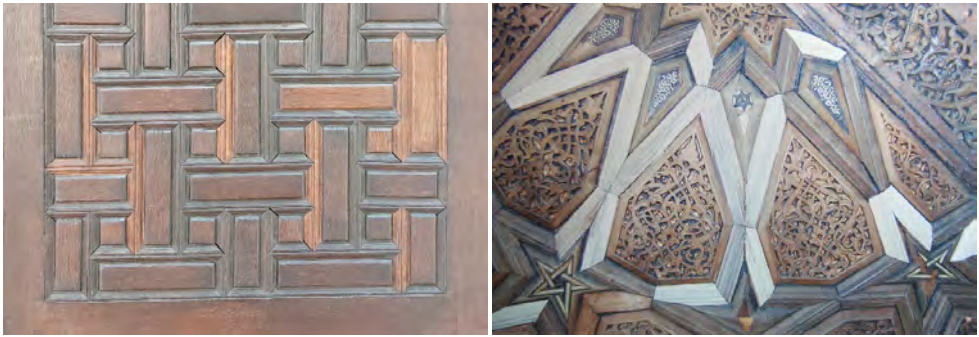
**Figure 14.** Partial repair on doors with rectangle and star kunderkari composition (Photo. C. Beşiktaş)

If architectural timbers, such as doors and window shutters, are highly decayed, their rotting parts can be replaced with new parts. The new piece should be selected in the type, color, and texture of the original, if possible, from well-dried, old timbers grown in the same region and impregnated before use. The new material should be prepared in a way that is formally compatible and does not impair the appearance and integrity of the historical member, but with details that are understood as modern material upon inspection, and the date of repair should be written on it. The fallen or rotten parts of carved and inlaid wooden elements may cause other components to slip and the ornamental order to deteriorate. In some applications, this situation is solved by leaving the places of the ornaments empty or supporting them with undecorated wooden blocks. By contrast, in some cases, carvings, ornaments, and inlays are completed with techniques and materials similar to the original (Sav et al., 2014, pp. 60-62) (Figure 14). Processing the new wood to be used in these areas with the original decorations is one of the issues that experts approach differently. Making an indistinguishable copy of the original piece contradicts the rule that the restoration is perceptible. However, the possibilities that the visual integrity disrupted by the flat faces of wooden blocks placed in the missing areas, the misunderstanding of the ornamental pattern, and, as the number of interventions increases, the inability to transfer the traditional technique and decorative details in the artifact to the future should be considered. This situation, which should be carefully evaluated during the repairs, has been resolved with a traditional preservation philosophy for the uninterrupted continuation of cultural heritage in Asian countries with rich wooden architecture that adheres to specific rules. The purpose of preservation is to replace the decaying pieces with new pieces produced by processing in the same manner as their ancestors did to preserve the originality of all historical elements of the heritage site and transfer historical knowledge and value to

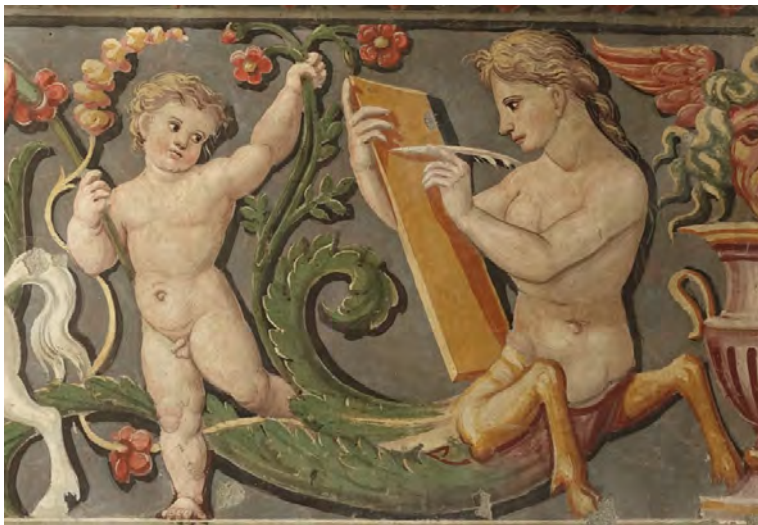
**Figure 4.** Detail of the frieze.

motif on all four walls: a central heraldic shield supported by two winged putti, touching a mythical figure of a woman with a phytomorphic tail from which acanthus gyral's are generated. Many of these figures wear headgear and have various hairstyles, but they are all writing with a stylus on a tablet supported by turned arms. Meanwhile, the gyral's host puttini that tighten their inflorescences, alternating to white-winged horses with horn. The gyral's design consists of the bust of an armed putto grabbing the horn of the fantastic animal and closing the motif, which is reflected the same way on the four walls. A fireplace surmounted by a painting accompanying the frieze, presenting the same motif of a large coat of arms supported by two winged putti and, in this case, two small heraldic shields next to it, can also be found on the south wall of Sala Riario, the subject of the restoration here discussed. The emblems depict Raphael Riario, Bagnaia, and the Gallo family, whereas the central coat of arms on the frieze belongs to Niccolò Ridolfi, one of the most important bishops who succeeded the Riaris. The coats of arms on the other walls belong to Federico Cesi (west wall), Agostino Spinola (north wall), and Marco Corner (east wall). In the other rooms, we find the coats of arms of Bagnaia and Gallo (Sala Gallo or Mascherone) and Giovan Girolamo de Rossi and Raffaele Riario (Sala de Rossi or dei Dolphins) once more. The paintings are lively and have the typical rhythm that exalts the family, revealing to us traces of the client's tastes and the artists' offer.

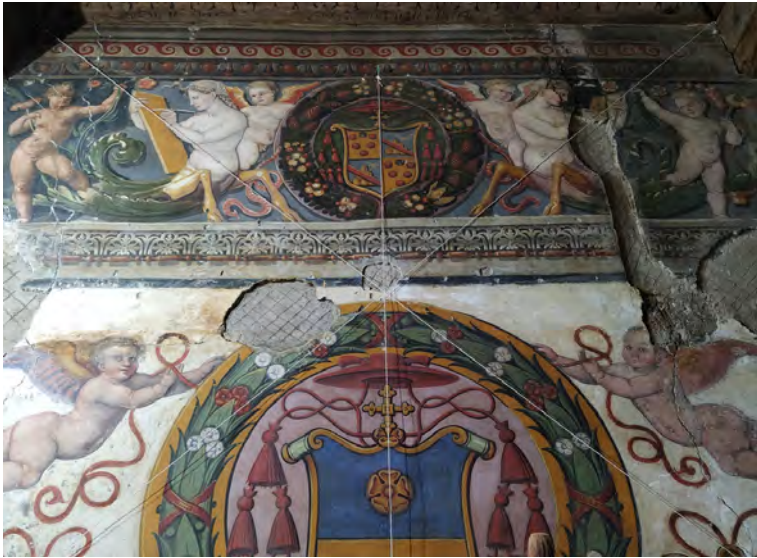
**Figure 11.** Strings stretched from the fireplace's frame to the beams. One can observe the construction lines of the painting. Just below Ridolfi's emblem, the points marked in correspondence of the string.

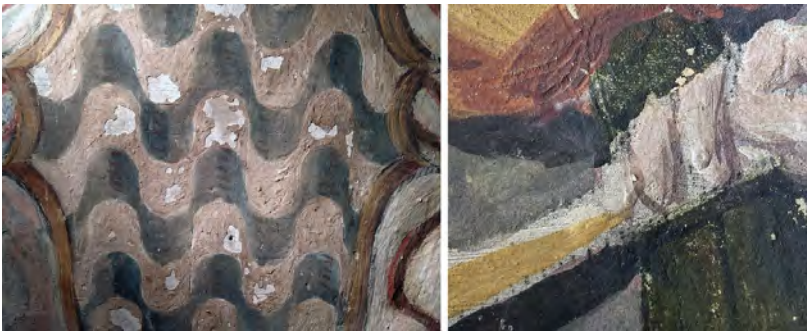
**Figure 12.** Regular etching under Bagnaia's coat of arm and spolvero for frieze's detail.

After dividing the area, the drawing model was carried on cardboard to extract both *spolvero* and indirect etchings. The indirect etchings, mainly found to the right of Ridolfi's araldic shield, were also used to draw elements and features of the coat of arms. Moreover, Bagnaia's emblem shows a grill that helped the painters apply the colors.

The *spolvero* is used to define the outline of the characters; it can be seen in see-through, very fine, and extremely close points (3–4 mm). The *spolvero* is also used when the drawing becomes smaller and more accurate, just as the figures' hands holding their ink pens or court swords.

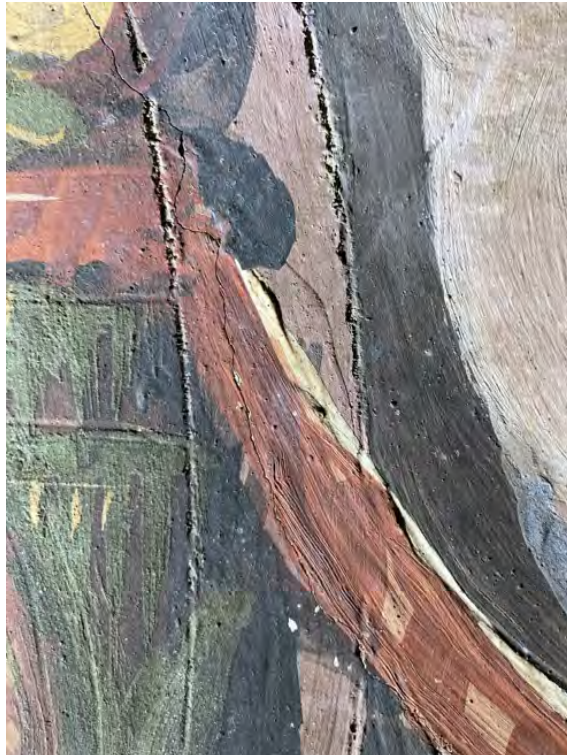
**Figure 13.** Overlapping of the pictorial draft and the brushstroke's matter.

To form the means and procedures of the artistic workshop, poly acetate transparency with the 1: 1 outlines trace was used. Finally, the correspondence of the cardboards was verified. However, the images showed small discrepancies with each other. It was hypothesized that the cardboard could have been segmented; likewise, it is reported in manuals and treatises on painting. In order to maintain the cardboard, several copies of the first one were obtained. The cardboards were generally used in the construction site because they could be easily cut and trimmed, turned upside down, or rotated because they had more handling and could also be used in parts. A peculiar feature of *spolvero* and etching is the minor variation in certain areas. For example, the right putti's hand is different from the one drawn with *spolvero* emerging from the underlying white background. Regarding the etchings, which are mostly on the right side, some do not exactly follow the final drawing on the frieze, particularly regarding the right part of Ridolfi's coat of arms.

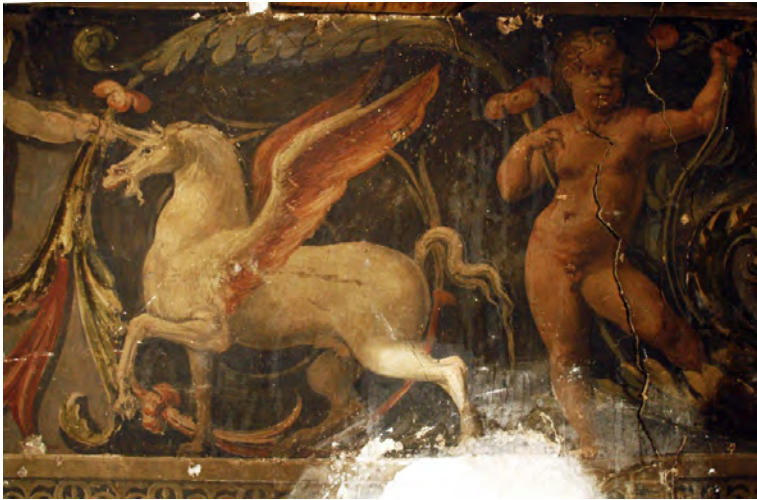
**Figure 15.** Details of the ancient restoration below the left beam.

The first restoration was completed between the end of the 16th and the beginning of the 17th centuries, and it runs almost entirely through the frieze from the ceiling to the upper frame of the fireplace. On the left, under the beam, the large area of the putti with the horse with wings, a piece of the lower frame of the frieze, the tip of the wing, and the right foot of the winged putti holding the Riario's crest can be seen until it is lost in the white background. On the right side of the painting, the re-make affects the area of the tablet of the female figure next to the frieze and the foot of the puttis suspended above the Gallo family shield, up to the corner of the peperino frame; this intervention's components have been lost or replaced. The same reconstruction can also be seen on the north wall, mirroring the first at the beam, where the unicorn with wings is painted, as well as in the de Rossi Room. The portions in the latter are more circumscribed, except for a larger area on the right side of the fireplace.

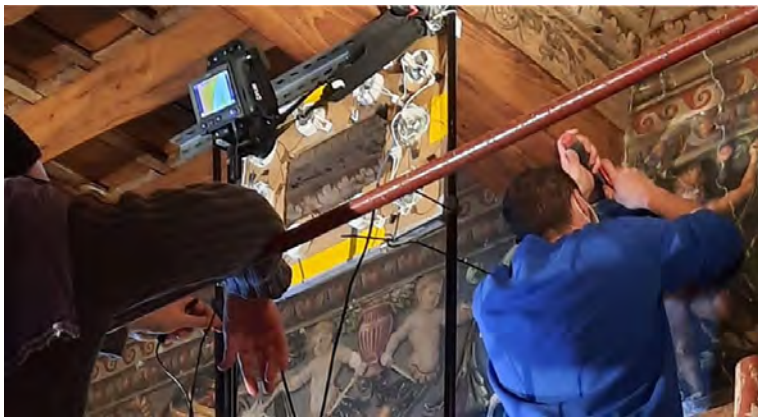
**Figure 21.** Thermography set during the consolidation (it is visible the thermocamera and the frame with halogen light).

As previously stated, consolidating the preliminary layer, a complex and delicate part of the intervention, necessitated the development of unique strategies. As a first step, areas of punctual detachment were distinguished from larger areas with substantial vacuum to be filled. Passing from the bottom up and using as much as possible the previous cracks, the paint adhesion defects above the fireplace and in the left area of the frieze were stabilized using Ledan TB1. Ledan Ristat B and Ledan Ristat Extra and Ledan Adhesive were used from the middle band's height and throughout the plaster deformation area. Using this injection mortar was decisive in fixing the most critical points, creating a sort of pinning that secures the support to the preparatory layers. The product's characteristics allowed it to be injected

without dripping, thus locally filling the vacuum; the operation primarily involved the middle and upper areas of the deformation and the left edge to fix the parts most susceptible to mechanical stress. The remaining vacuum was filled with successive injections of Ledan Ristat (B and Extra), each time adhering to the setting times specified in the technical data sheets. Consolidation was also performed using small pipes to fill the detachment as much as possible while gradually closing the cracks and holes with mortar when necessary.

A special collaboration with the University of Calabria was used to investigate pulsed compression thermography (PuCT) in order to more articulately analyze the relationship between the incidence of adhesion defects and the consolidation of preliminary layers during restoration. Exploiting classical thermography techniques (Volinia, 2004) and with the support of fine processing, the object's material continuity is recorded through the penetration of the thermal pulse and its propagation. This non-destructive technique illustrates the behavior of thermal waves resulting from an intermittent impulse at set times; thus, the impulse's absorption, refraction, or reflection can be seen in thermograms. At a minimum heating (around 2°C), compatible with the object's conservation, variations in the intensity of the gradation in the pre-painting layers would suggest discontinuities in the plaster. The advantage of active thermography over passive thermography is a more restrained shot capable of identifying the layers of the painting and is not limited to global information on the surface; however, it is less immediate and forces the analysis to a not overly large framing.

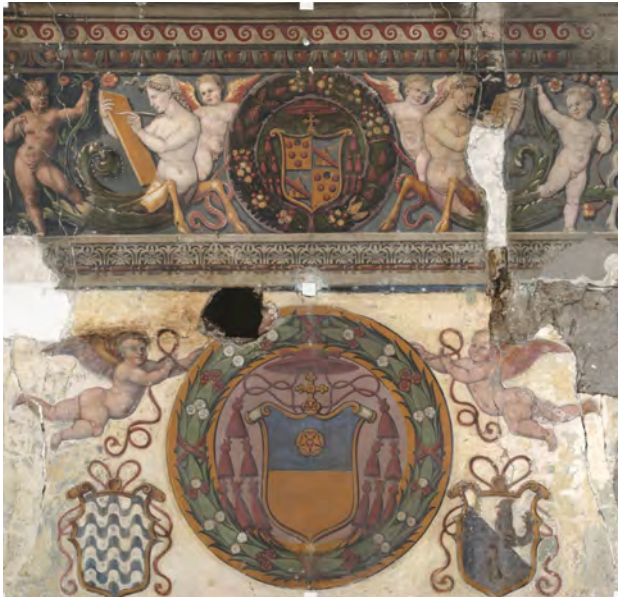
**Figure 25.** Frieze and paintings of the fireplace during the restoration and the HMI shots.

The coats of maintenance paint and whitewashing in the paintings on the fireplace were completed in stages. Following a preliminary cleaning of the area to better understand the succession of layers, the most recent ones (the green S5) were removed by experimenting with various systems, the best and most manageable of which turned out to be scalpel and dry method. Specific research was conducted into using white backgrounds in heraldic painting, on walls and fireplaces, and coats of maintenance paint removing were applied up to the first repainting of the background, covering nearly the entire area. The decision was thus made to remove the colored coats of maintenance paint, bringing the background down to this level, and, with a lengthy finishing operation using scalpels, brushes, and melamine sponges, it was freed of any residual overpainting.

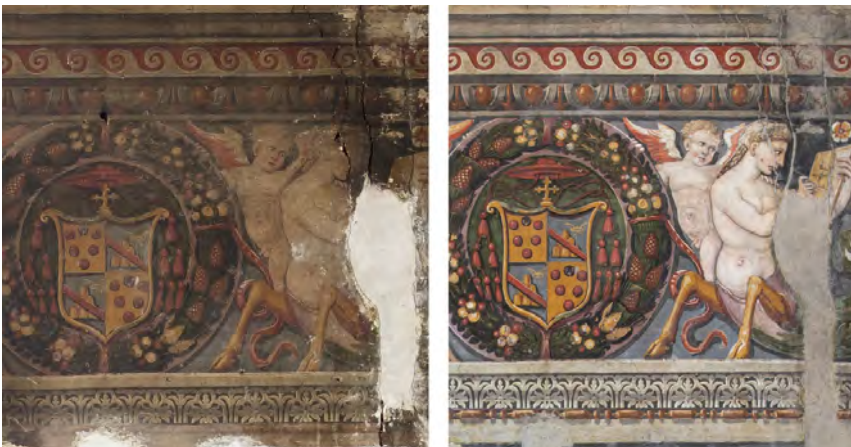
**Figure 26.** Comparison between part of the frieze before the restoration's intervention and after the aesthetical revision.

Following the restoration of the masonry structure's continuity by inserting two shaped bricks into the hole of the smoke duct, an aesthetic overhaul was carried out, in keeping with the previous restoration work at Tuscia University. Where necessary, the large cracks were filled with an under-level grouting, composed of lime, pozzolan, and river sand (1:1,5:1); they were worked in such a way as to appear rough, to imitate the curl. The finer sifted mortar was used to close deeper cracks. The nail holes were filled level with a mixture of marble powder and slacked lime paste (2:1) to be re-taped later. The lacunae in the background of the paintings above the fireplace, which were scratched out in the outer parts during the time of the first coats of maintenance paint, were filled with a mortar made of micronized calcium carbonate powder and lime (2:1). The decision not to level the large void is due to the need to wait for the restoration of each portion of the frieze in order to fully assess the appropriateness and best strategy for reintroducing these flaws, which, in any case, testify to an ambiguous period in the Hall's history.

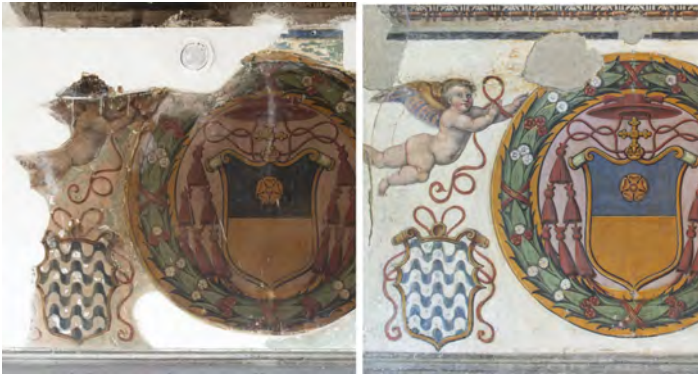
**Figure 27.** Comparison between part of the paintings of the fireplace before the restoration's intervention and after the aesthetical revision.

It was necessary to balance an impoverished situation on the fireplace paintings and the frieze band, which, as seen, was weaker at the structural level, in order to give the painting new unity through retouching. For the reintegration, Winsor & Newton watercolors were used, with special emphasis on ivory black and soils; the integration of the lacunae with marble dust was mimetic, but distinguishable at close inspection, and the fillings on the white background were veiled to balance them with the surrounding painting. Where the pictorial surface appeared abraded, spatulate, or fallen, a smoother view of the image was restored, making it easier to appreciate the compositional balance. Finally, isolated dark spots on a white background were softened with isopropyl alcohol-diluted Gamblin varnish colors.

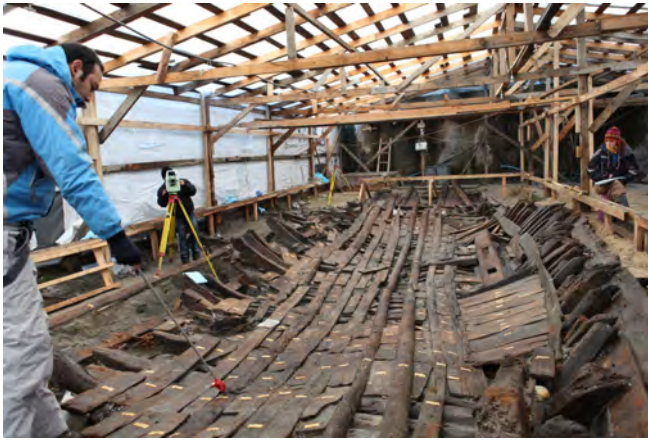
**Figure 1.** Total Station survey at a Yenikapı Shipwreck (IU Yenikapı Shipwrecks Project Archive).

Earliest methods relied on simple sketches and illustrations, which, in some cases, were enhanced through the addition of section drawings and detailed site descriptions (Maarleveld, 1997; Muckelroy, 1978). The introduction of modern diving gear allowed nautical archaeologists work on shipwrecks underwater around 1960's. The early scientific excavations conducted underwater brought traditional survey techniques and equipment into the underwater environment. These techniques included the implementation of a grid system, the use of tape measures, plumb lines, and the application of triangulation methods. However, the limitations inherent to the underwater environment, particularly diving time constraints, immediately necessitated the development of more practical and faster solutions. As a result, stereo-photogrammetry, which was used for "as found" recording of the Skuldelev ships in Roskilde, was later implemented underwater during the Yassiada Byzantine Shipwreck Project in Bodrum-Turkey in 1963 (Crumlin-Pedersen, 2002, Bass, 1975). While photogrammetry continues to be employed today with more advanced software and high-resolution cameras, its effectiveness underwater relies heavily on clear visibility conditions at the site. In 1980, the challenges of recording in low visibility conditions during the Mary Rose Project were overcome with the introduction of an innovative software known as the "Direct Survey Method (DSM)." This method was specifically developed for the underwater sites with limited visibility that are characterized with complex three-dimensional architectures. The DSM involved taking tape measurements directly from reference points to the object being surveyed, allowing the determination of precise points in three dimensional space. By employing the DSM, researchers were able to achieve much faster and more accurate recordings with quantifiable error (Rule, 1989). After the last decades of the 20th century, the use of digital techniques became commonplace in nautical fieldwork. While total stations and CAD software were the preferred methods for recording ships on land, the application of photogrammetry and the Direct Survey Method (DSM) became more widespread, particularly for underwater recording. Rescue projects have greatly benefited from these techniques, as they mitigate the pressures exerted by various stakeholders and, consequently, minimize the potential impact of modern development on archaeological sites. For instance, during the rescue excavations at Yenikapı, Istanbul, nearly all of the 37 early medieval boat remains were effectively recorded in the field using total station surveying techniques that allow archaeologists to save all boat remains while working within demanding construction timelines (Figure 1) (Pulak, 2015; Kocabaş, 2015; Özsait-Kocabaş, 2008).

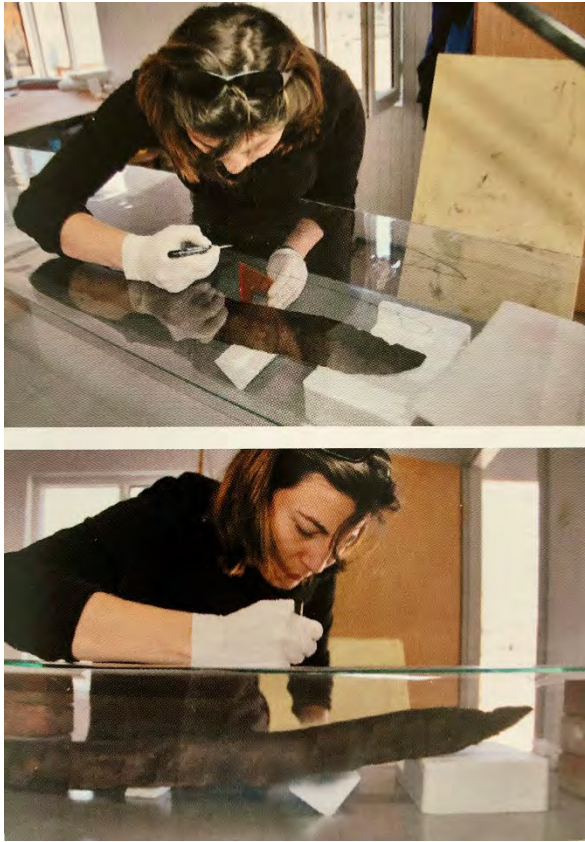
**Figure 2.** Elevated plane tracing of a ship timber (IU Yenikapı Shipwrecks Project Archive).

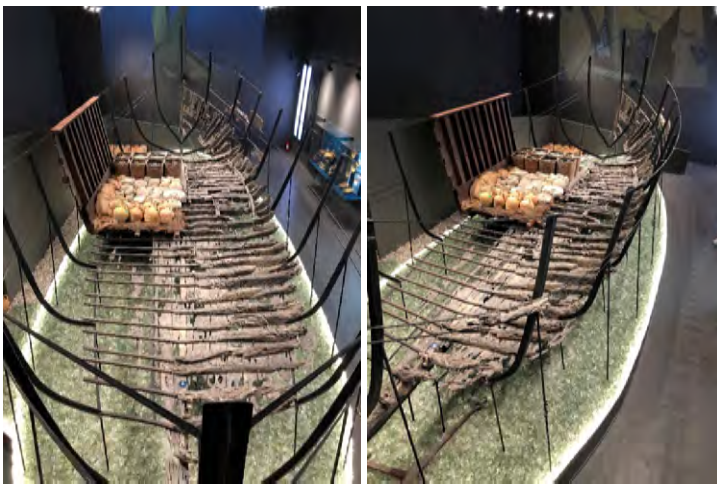
**Figure 6.** Serçe Limanı Shipwreck in Bodrum Museum of Underwater Archaeology  
(Photo. E. Türkmenoğlu).

The ships displayed in museums are typically placed on support structures known as ship cradles (Figure 6). These cradles are specifically designed to provide stable and secure support

for the ships while they are exhibited. The primary purpose of ship cradles is to distribute the weight of the ship evenly, preventing any excessive stress or strain on specific areas of the hull. The majority of the supports are made of stainless steel, a preventive measure taken against oxidation, which is the most formidable enemy of wood conserved with PEG. In addition to corrosion resistance, the cradles are expected to possess flexibility, rigidity, and durability (Fix 2015; Stein 2017). They should also be reversible, easily accessible to aid in preventive conservation, and visually appealing for visitors. Although designers of ship exhibitions take these factors into consideration, most ships in museums are susceptible to deformation and experience a noticeable reduction in strength and resistance to creep over time. As a result, monitoring of ship hulls on display is crucial to detect any geometrical changes and implement appropriate solutions to prevent further deterioration. Several museums, including Vasa, Mary Rose, Arles Rhone 3, Oseberg, and Bremen Cog, have embarked on long-term maintenance projects for their ships and have implemented digital monitoring techniques to identify and track structural changes. Spatial monitoring, which requires high precision, has been implemented through the installation of Total stations, 3D scanners, and photogrammetry in various museums. These technologies enable accurate measurement and monitoring of ship exhibits (Colson et al.,2022; Colson et.al. 2022). One such example is the Vasa Museum, where spatial monitoring has been instrumental in identifying structural issues and the obtained results have dictated the need for the renewal of support structures. The design of new support structures can now be pre-designed through models and tested using digital technologies, unlike their predecessors.

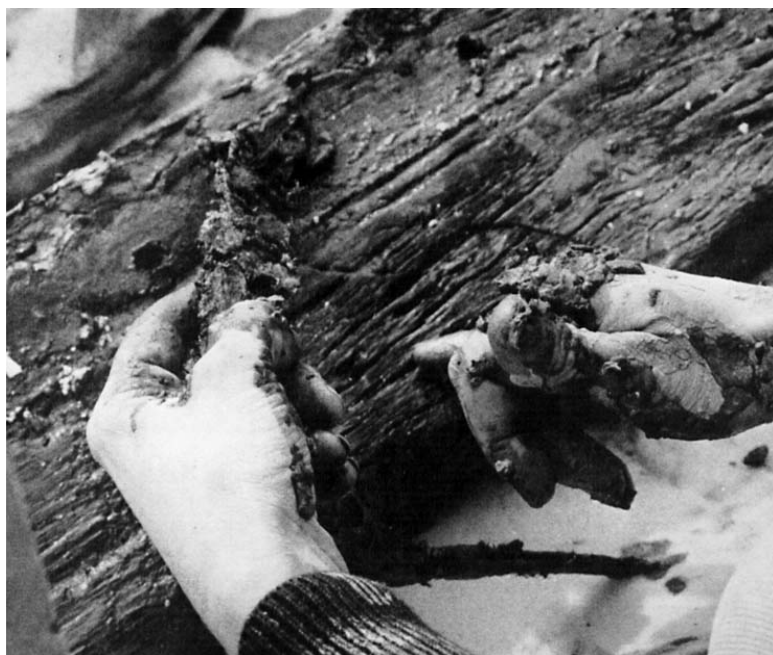
**Figure 9.** Luting of animal hair pierced by clench-nails (Evans, 1971, p. 114).

Luting was used on both ships. While the content of the luting material on YK20 could not be definitively identified, cattle hair is estimated to have been used in the luting material on the Graveney ship. The iron clench-nails fastening the planks had almost completely rusted but left a clear impression of their shape on the timber (Figure 9), which is a huge distinction from YK20, which used edge fasteners as dowels (treenails). However, wedged treenails fastened the massive frames to the planking of the ship (Figure 10), just as in YK20. Although the butt scarfs used in the Graveney boat do not resemble the S-shaped and diagonal scarfs used in YK20, they do match some other Yenikapı shipwrecks (YK17, YK27; Kocabaş, 2015, p. 12). In addition to the luting used in both ships, a light brown resin was observed to have been used extensively on YK20, with the remains of a very hard grey-colored adhesive also found in some areas. However, researchers have mentioned the remains of a layer of clay

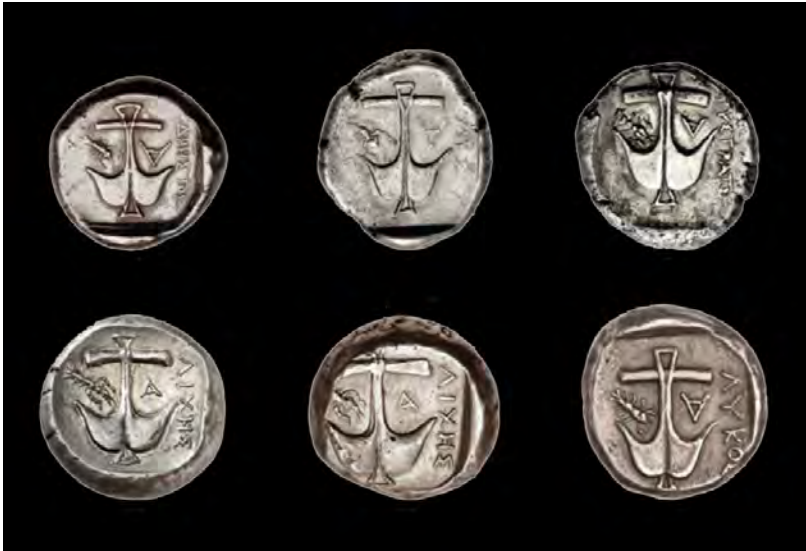
**Figure 4.** Depictions of wooden anchors with stock on *Apollonia Pontica* coins (Paunov, 2017, p. 84).

the second half of the 6<sup>th</sup> century BC was also found in the Dattier Shipwreck. In addition, wooden-anchor depictions first appeared on coins dating from 600-400 BC. Almost all of these depictions on coins strikingly show quite thick arms and a buoy ring on the stock and crown, which allows the anchor to be pulled up in case it gets stuck on the bottom or breaks. Depictions were first found on the coins of Apollonia Pontika<sup>3</sup> (Fig. 4; Kapitan, 1990, p. 243; Paunov, 2017). However, when examining the descriptions of anchors on the coins recovered from *Apollonia Pontica*, the anchor body is understood to have contained two shanks and the arms to have been composed of pieces adjacent to this body shank. These shanks were probably cut from a large tree with one or two branches. Until the discovery of the Karaburun Anchors, how these two pieces that make up the wooden anchor were put together had remained unknown.

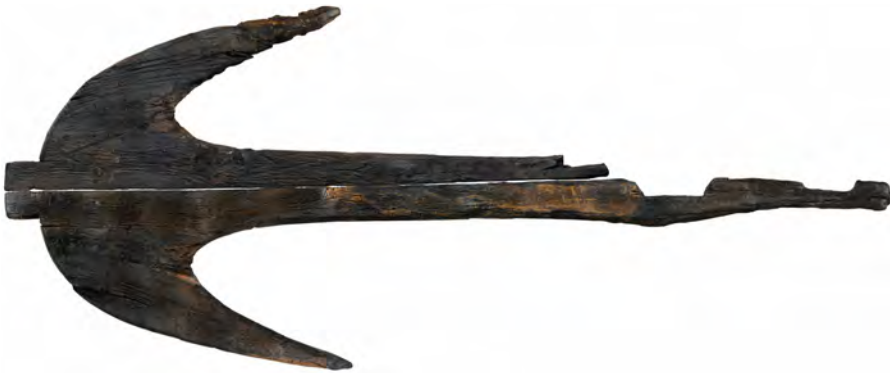
Figure 6. Karaburun Anchor 1 photo-mosaic.

A general description of the find reveals a double-armed anchor that is considered whole with its shank and arms; it is composed of two equal parts formed by dividing it into two along the axis of symmetry. In short, each part has one arm and half of the shank axis. These parts are named KA1-1 and KA1-2. KA1-1 was found intact with the shank, arm, and head parts; the length of the piece measures 460.5 cm. KA1-2, on the other hand, was broken at a point very close to the beginning of the stock-aperture, and most of its head was missing. The current length of the piece up to the fracture is 315.7 cm. Apart from these, no other element that could belong to this anchor was found.

The wood from both parts is rugged and robust. However, the most extensive damage to the pieces occurred in the form of deep cracks from the outside to the core due to being exposed to rapid moisture loss, especially on the faces of the anchor pieces taken from the sea. Apart from this, surface losses are found in the form of scorching due to occasional wear and excessive drying on the surfaces.

These two anchor pieces are joined by four mortise and tenon joints on the body parts, and the tenons are fixed in place with the peg that act as a lock on both sides. In addition, three more mortises on the head part of the anchor are seen to pass through the piece in the horizontal direction.
